Swarthmore College Timber Bridge: A King (Post) Among Bridges

Advisor: Professor Faruq M. A. Siddiqui
Swarthmore College
E90: Senior Design Project
May, 2007

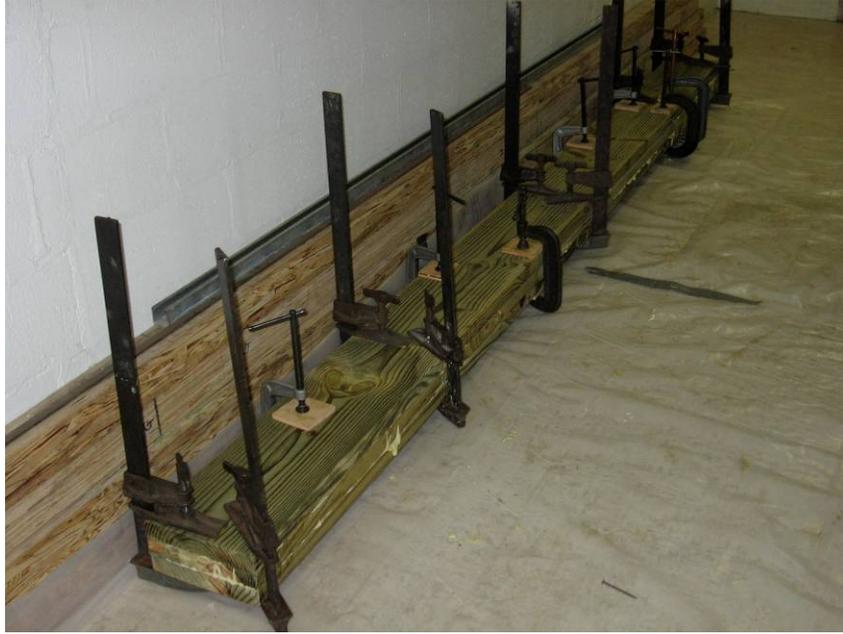
The three girders and the two center diaphragms were built-up members, constructed using the following procedure. For the diaphragms, this was necessary to fit the width of the Simpson Strong-Tie custom connections, while for the girders, this was necessary to span the 3.8 meter gap while complying with article II.b, and having no individual member longer than 2.1 meters. The highest quality timbers from our available supply, those members with the fewest visible defects, were selected and cut to the proper dimensions for gluing and screwing. Before assembling each beam, its components were dry-fit and examined to ensure optimal grain direction, dimensional accuracy, and flushness. The components were then laid flat, side-by-side, and wiped down with a damp cloth. A layer of Gorilla Glue was applied as quickly as possible to one side of the components being glued. The components were then placed together, nailed together to prevent any sliding while being handled, and tightly clamped, as shown in figure 5.1.

Figure 5.1: Fabrication of Built-Up Girders: Clamped after Gluing

There were approximately two clamps per foot of beam being glued. The beams were then left clamped overnight for the Gorilla Glue to cure under pressure. The clamps were removed the following day, but the girders were not screwed together for several days because the screws had not yet arrived. As a result of the Gorilla Glue expanding and inherent flaws in the wood, some of the individual members in each girder warped away from one another. This was partially corrected by inserting wood glue into the crevices once the screws had been installed. Once all the screws were in place, the original positioning nails were removed. The screws we used were stainless steel auger point screws, provided by McFeely's Square Drive Screws, as shown in figure 5.2.

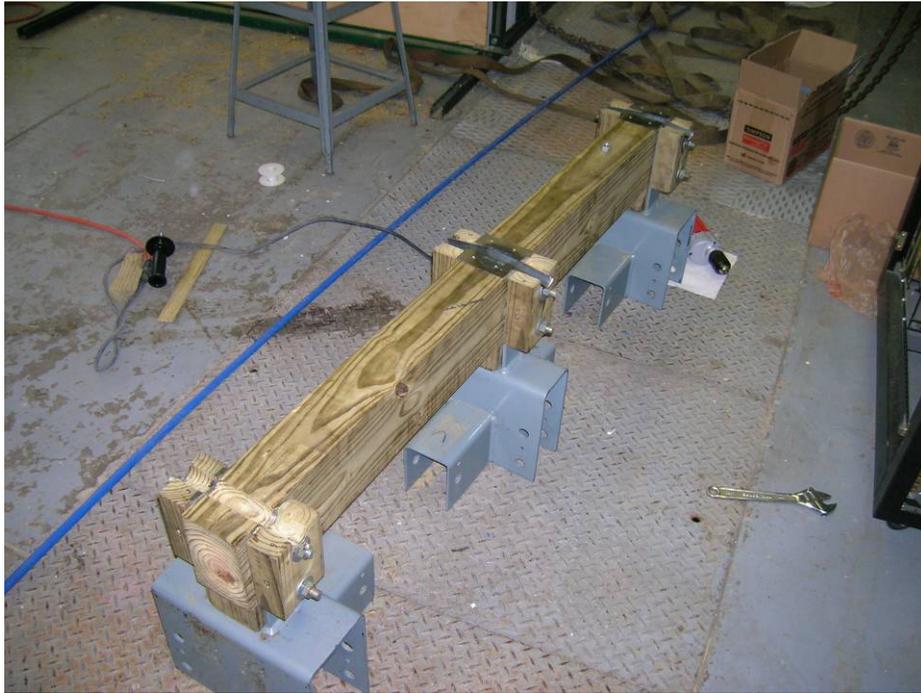
nuts. The very bottom of the connectors had to be milled off to meet the maximum depth of understructure constraint from article II.g and provide room for the cables. Underneath each connector, a semi-circular path was carved out using a Dremel rotary tool to make room for the 1" outside-diameter steel half-pipe. A picture taken during this process is shown in figure 5.6.

Figure 5.6: King Post Construction Showing Milled Grooves and Half-Pipes

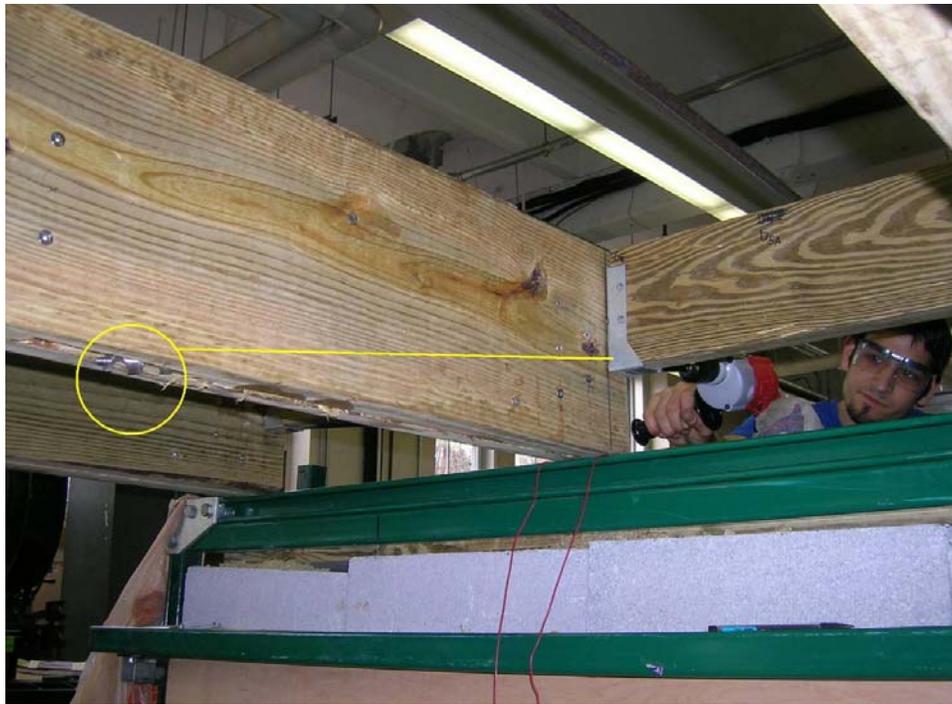
In order to accommodate the 1/2" cables (5/8" thick with sheathing), 3/4" holes were drilled from the center of the ends of the girders downward at an angle of 10.24°. We found that drilling the 28" holes from both ends with a 15" drill bit was exceedingly difficult. An aluminum guide was built to ensure that the holes were at the correct angle and did not significantly veer off in any direction. The guide would be nailed into place, the whole would be drilled, and then the guide would be removed. While the guide helped, we still found that our two holes were not meeting in the middle of the girder. We were finally able to drill each hole using the guide, and a wood drill and drill extender purchased from Home Depot. A view of the wood drill extending through the entire hole can be seen in figure 5.7.

Figure 5.7: Wood Drill and Extender Going Through the entire 28" Hole

Had we understood the qualities and existence of wood drills, we could have saved much time, frustration and money on buying long metal drills, which were inadequate to the task anyway. The metal drills not only required us to drill the cable holes from both ends, which proved very difficult, but also could only be used for 1/2" at a time. With no central bore, the metal drills did not remove material like the wood drill, and would soon begin to compress wood pulp at its tip rather than continue drilling. We were finally saved from this frustration by John Charles' father, who suggested using a wood drill with extender for a much cheaper and more effective solution.

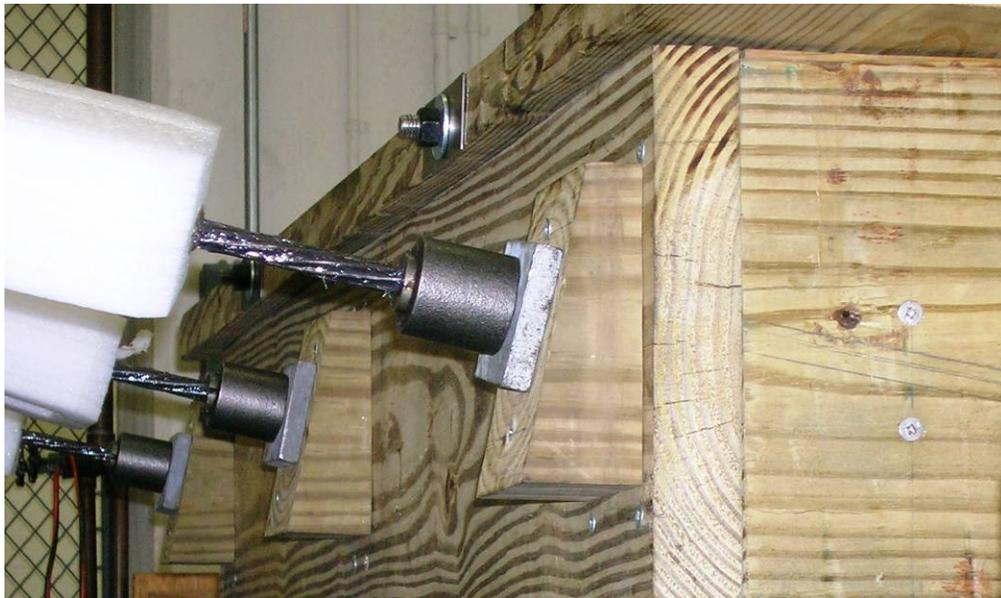
The cables were anchored on each end of the bridge with T-5 anchorages provided by VSL, a schematic of which is shown in figure 5.8. The header plate, anchor blocks, cables and anchorages are shown in-situ in figure 5.9.

Figure 5.9: Close-up of Header Plate, Anchor Block, Cable and Anchorage

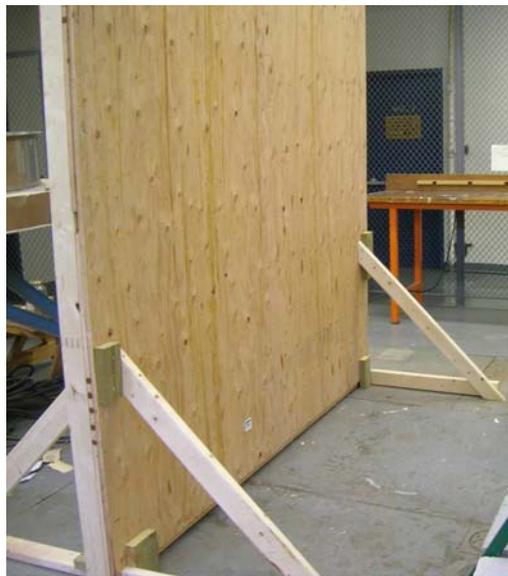
We pre-tensioned the cables 48 hours prior to loading with a ram provided by VSL. The cables under the outer girders were pre-tensioned to 1500 lbs for both outside cables, while the central cable was pre-tensioned to 1000 lbs for the center cable. The ram calibration curve, along with additional data and schematics for VSL cables and tensioning systems is included in Appendix C. In order to meet VSL workplace safety requirements, we erected an eight foot square wall to stand directly behind the cables being pre-tensioned, thereby obstructing any cable that should slip and break away from the bridge under high load. The wall consisted of two layers of 3/4" thick plywood nailed together, and then to a 2x4 frame. The wall is shown below in figure 5.10.

Figure 5.10: 8' x 8' Safety Wall

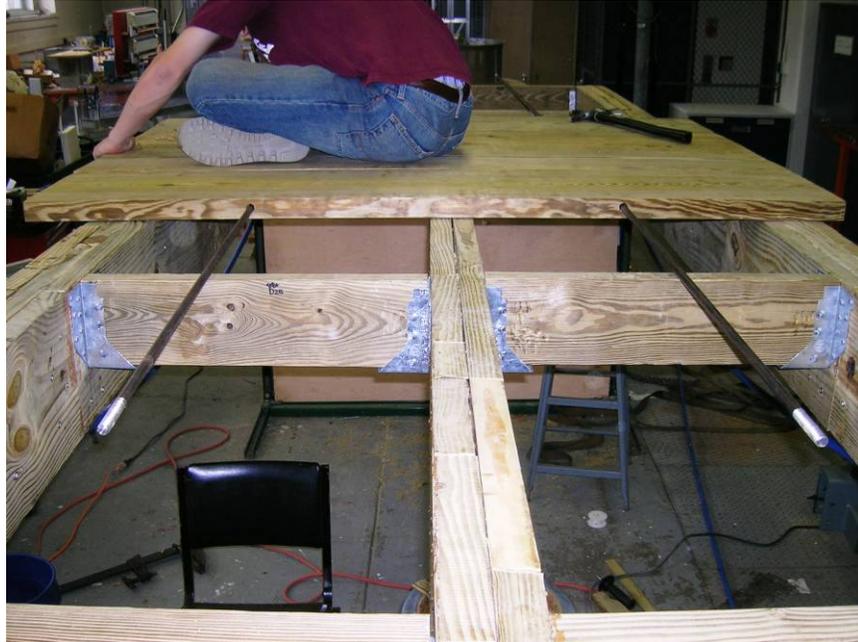
The deck consisted of 13 2x12, and 2 2x2, planks resting transversely on top of the frame, with 2 1/2" steel rods passing longitudinally through all deck panels at 1/3 and 2/3 the width of the bridge. For each deck panel, we undertook the tedious process of precisely marking the holes, securing the panel perpendicular to the drill-press with clamps, and then drilling the holes from both ends. A 5/8" drill bit was the largest drill bit that passed entirely through each panel, but a 3/4" drill bit was used on the outside thirds of each panel to provide play where the planks came together. With this extra wiggling room, the panels were worked onto the rods by pressing a wooden block on the edge of the panel between the rods and lightly hammering. This process is illustrated in figure 5.11.

Figure 5.11: Deck Planks Being Pushed onto Deck Rods

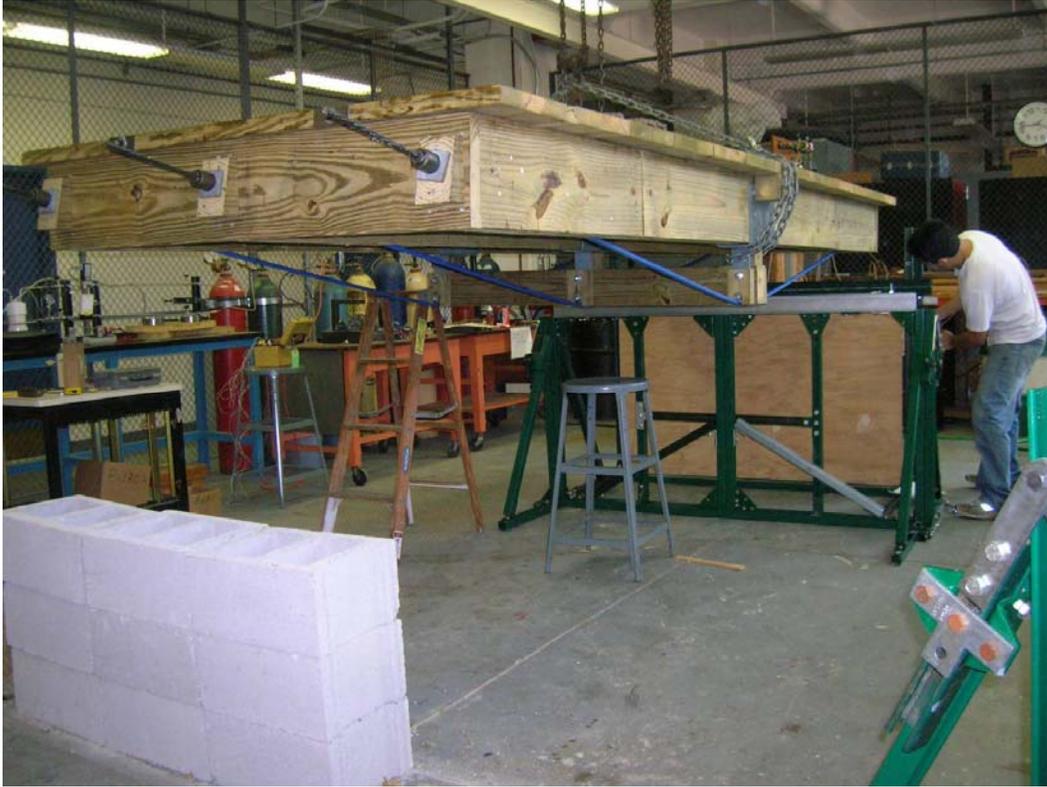
One reason we chose the Hicks basement cage was for the translating mechanical assist pulley system, which would allow us to weigh the bridge. This system consists of two parallel beams that are spanned by a third beam on rollers. Attached to the third transverse beam is a pulley assembly also with rollers. As a result of this design, this system can be used anywhere in the basement cage area. It has been rated for a maximum load of one ton. Due to the load rating of the lift, we performed wood volume calculations to confirm that the bridge, when lifted for weighing, would not exceed the load rating. In order to weigh the bridge, we connected a calibrated strain gauge transducer to a hook attached to the pulley. We then wrapped chains around the mid section of the bridge, where they could be wrapped around the metal connectors and not dig into the wood, and hoisted the bridge into the air. The strain gauge transducer was attached to a signal conditioning box which listed a value of $5418 \mu\text{strain}$, equivalent to 985 lbs. This entire assembly is shown in figure 6.1, and with another angle of the suspended in bridge is shown in figure 6.2.

Figure 6.2: Bridge Suspended About Mid-Span Connectors During Weighing

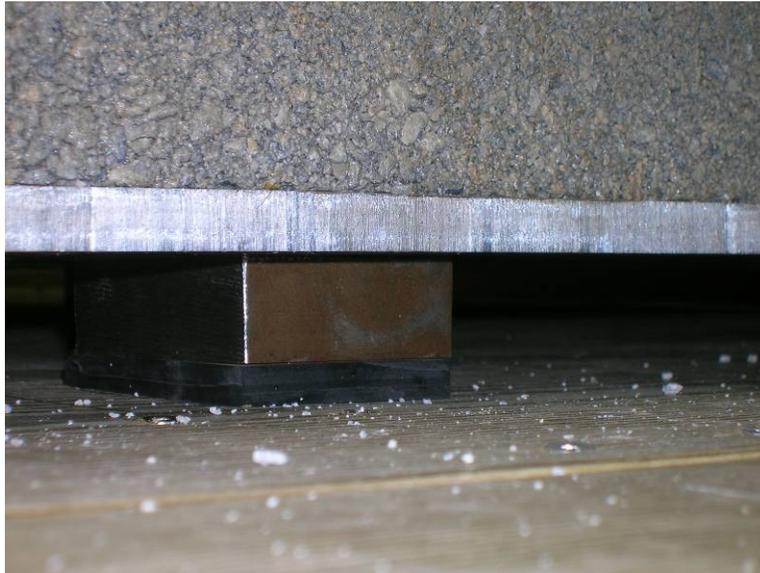
to ensure adequate support for the 20 kN load, and prevent a bearing failure of the wood in direct contact.

Figure 6.4: Close-up Detail of Loading Point Transfer Mechanism

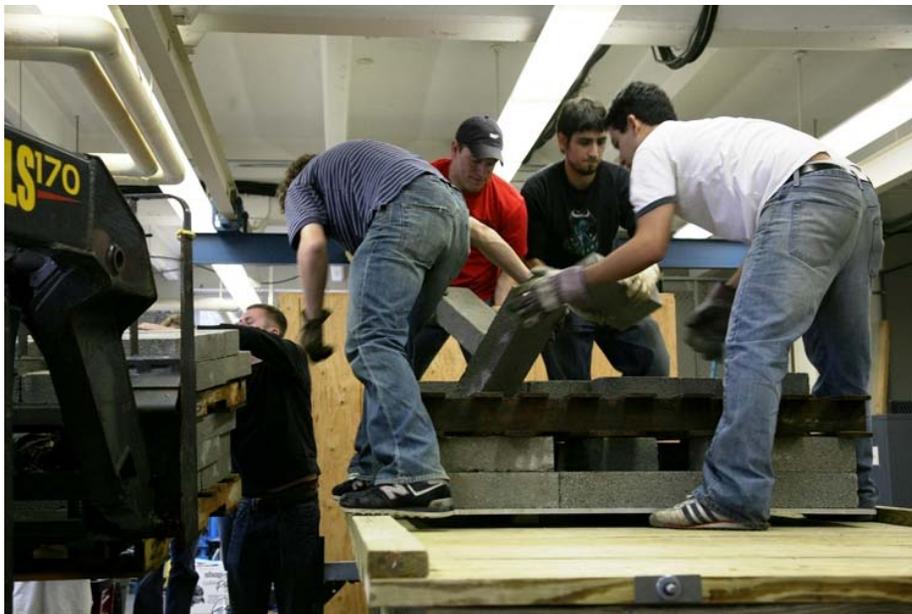
The four loading increments were prearranged on pallets that were then brought to the bridge by a forklift. Since there was not enough space for the forklift to unload the pallet and back up, each load of blocks was arranged symmetrically over the four loading points by students, with small calibration weights used to complete each full quarter increment. This process is illustrated in figure 6.5.

Figure 6.5: Manpowered Loading Process

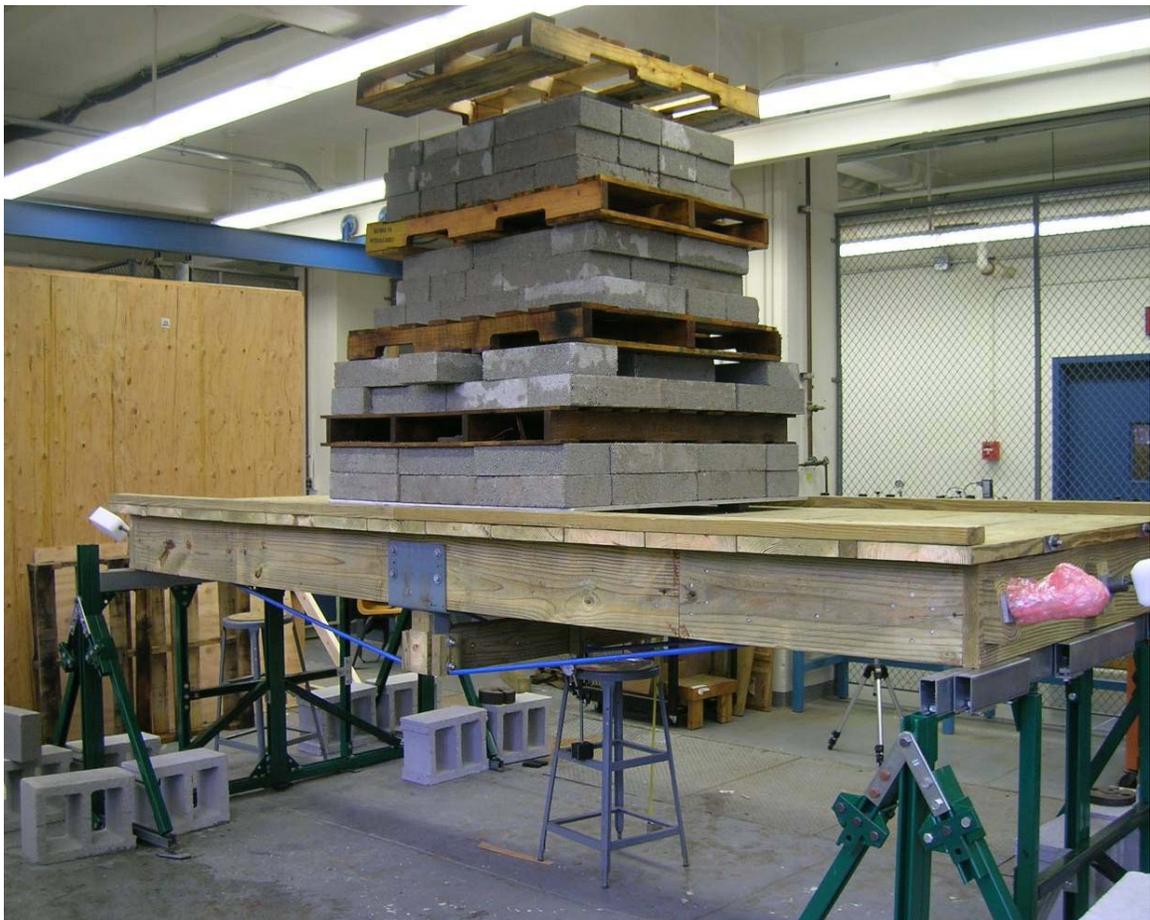
Since it had been raining for hours before loading, both the blocks and the palettes had gotten heavier, and we made slight adjustments to each load increments. This loading process was carried out once to determine overall bridge deflection with the load placed directly in the center, and again for deck deflection with the centroid of one loading block placed directly over the centroid of the largest deck panel. The first loading took 18.5 minutes to complete while the second took only 10 minutes. A picture of the bridge supporting the full 20 kN load is shown in figure 6.6.

Figure 6.6: Trimetric view of Bridge Supporting Full Load

As the load came to its full value, we observed no discernable audible or visible signs of change, besides a significant tightening of the cables. In the hour following the application of the final load increment, the bridge deflection crept an additional 4.0%. The total bridge deflection of 8.66 millimeters was greater than the predicted deflection of 4.5 millimeters obtained from our ANSYS analysis, but since the structure was designed conservatively, the deflection was still within allowable limits. Explanations for our excessive bridge deflection will be presented in the discussion section. The deck performed as expected, with the longitudinal steel rods transferring the force of the load from one deck plank to the next, and limiting deflection to only 28% of the allowable value. Interestingly, 45 minutes after achieving full load, the deck had stiffened such that the net deck deflection stopped creeping, and only the girders crept more. Throughout the loading cycles, the center girder experienced slightly higher deflections than the outside girders due to its thinner cross-section and higher load. There were no apparent asymmetries in the girder deflections that might point to fabrication inconsistencies, uneven stresses in the cables, or anchorage eccentricities. The deflection results and calculations are summarized below in Table 7.1. Net deck deflection was calculated by subtracting the average deflection of the beams on either side of the deck area from deck deflection.

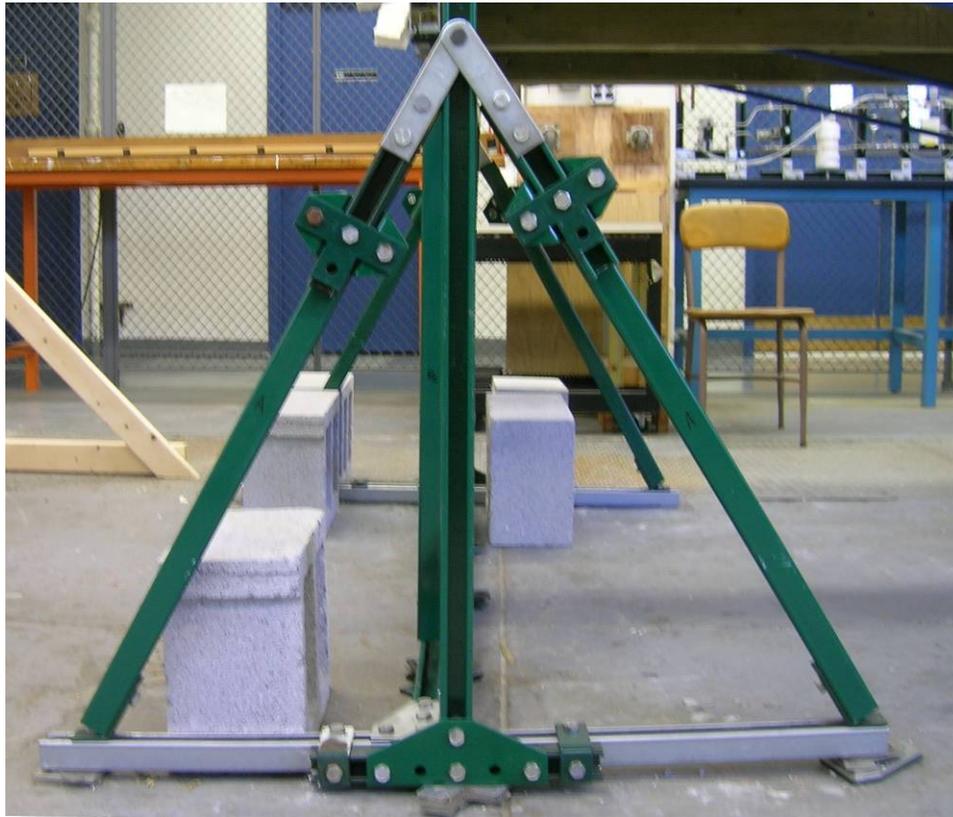
unaccounted for bridge deflection to the supports. Due to time constraints, we unfortunately did not monitor support deflection during loading. We performed a test with a team member's weight over the supports, and linearly extrapolated from that a support deflection of about 2 mm at full load. Since this was already over an order of magnitude higher than expected, there were clearly some incorrect assumptions in our model. Two differences between our actual frame and the ANSYS model frame which added significant deflections were the use of bolted connections, and the slightly out-of-plane orientation necessary to achieve crossing struts, as can be seen in figure 8.2.

Figure 8.2: Side Elevation of Unistrut Substructure Showing two Transverse Planes and Shimming

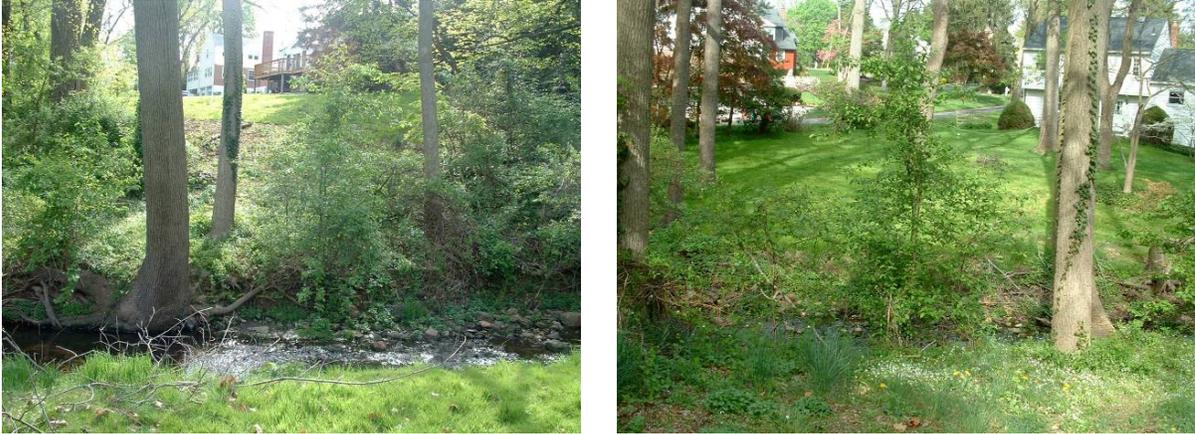
Figure 9.2: Proposed Bridge Location, End Views A and B

The bridge will span Dicks Run Creek running through Professor Everbach's backyard. End views of the bridge location are shown below in Figure 9.2. Property on both sides of the creek is owned by Professor Everbach, making any spanning operation viable.

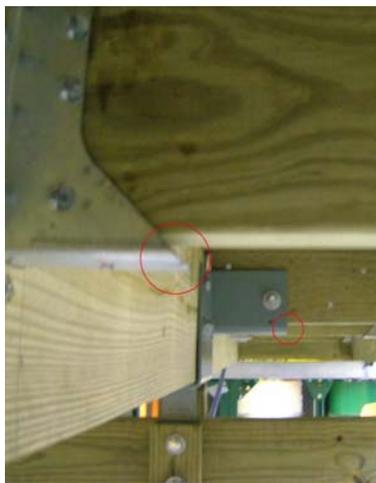
With no significant construction or wood-working experience, our team faced a steep learning curve, which we surmounted through much trial and error, and a little research. The major lessons learned are provided in this section in roughly the order they were discovered. Our girders were the first major components to be constructed, and they were not at all properly prepared or joined. All composite girder members should have been planed and leveled to identical dimensions before gluing and screwing. This would have saved the significant time spent on planing and leveling all girders, which required the most work but were too large to be brought back to the shop after assembly. The tops of the girders were leveled by cutting thin strips of timber in various sizes and gluing them on. Diaphragms were leveled from underneath by placing timber shims into the hangers. This can be seen in Figure 10.1.

Figure 10.1: Diaphragms Requiring Bottom Shims

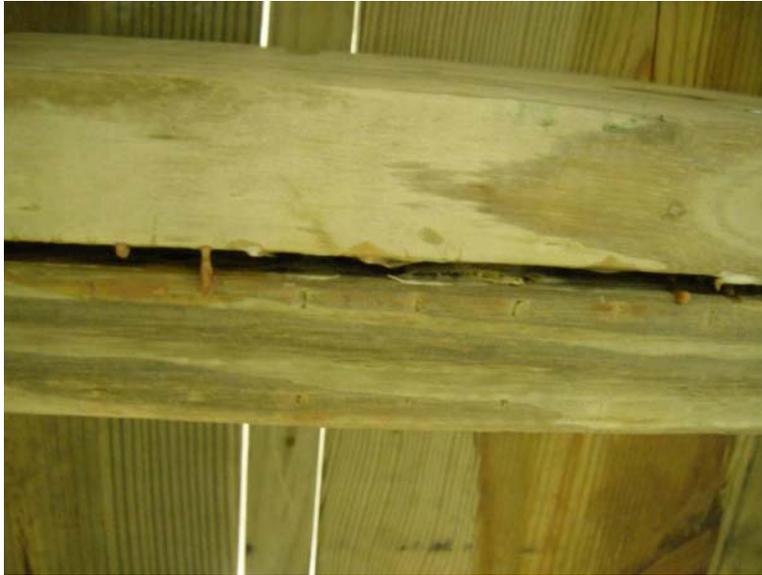
As mentioned in section 5.1.1, all composite beams underwent significant warping because they were glued and clamped together, but not screwed together until days later. This was a mistake that occurred due to the unavailability of screws at the time of glueing, but due to time constraints and a limited supply of clamps, our only other option would have been to place weights on the beams for days on end. This method was used with reasonable success for straightening some of the more warped deck panels. A photo of the results of this poor planning is shown in Figure 10.3.

Figure 10.3: Gaps on the Bottom of the Central Girder due to Warping

The wood was also never perfectly straight, and was often bowed or curved. We encountered many problems when we tried to attach the bowed 2x10s together to form the built up longitudinal beams. As a result of using the bowed wood, the individual members of the girders separated from one another after the glue dried and we removed the clamps. The bowing that we observed may have been a result of the low wood grade and would therefore have been minimal with structural grade timber. Had we planned adequately to receive the screws prior to gluing the girders, this might have been avoided as it would have forced the wood to overcome the strength of the screws and the glue to bow back.

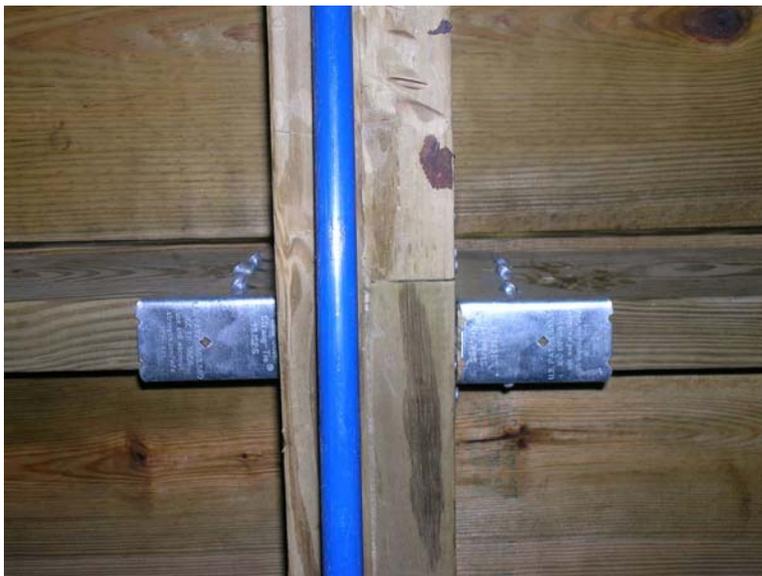
When our connectors arrived, we discovered that the outside girders were too wide to fit into the hangers. We initially used a hand sander to remove 1/2" from the width of the girders along 11" of their length. In addition to being extremely time consuming, dirtying our workspace, and leaving the surface of the wood wavy because of differences in density.

Figure 10.4: Quarter Point Diaphragms Staggering

diaphragms do not meet up at exactly the same location. They were shifted off-center in opposite directions by half a nail diameter so that the nails would not collide with one another.

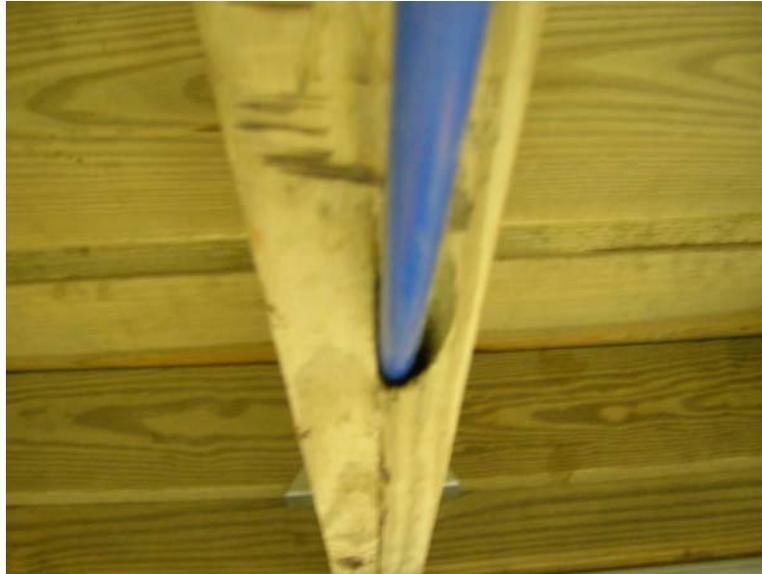
Figure 10.5: Cable Exiting Central Girder Slightly Off-Center

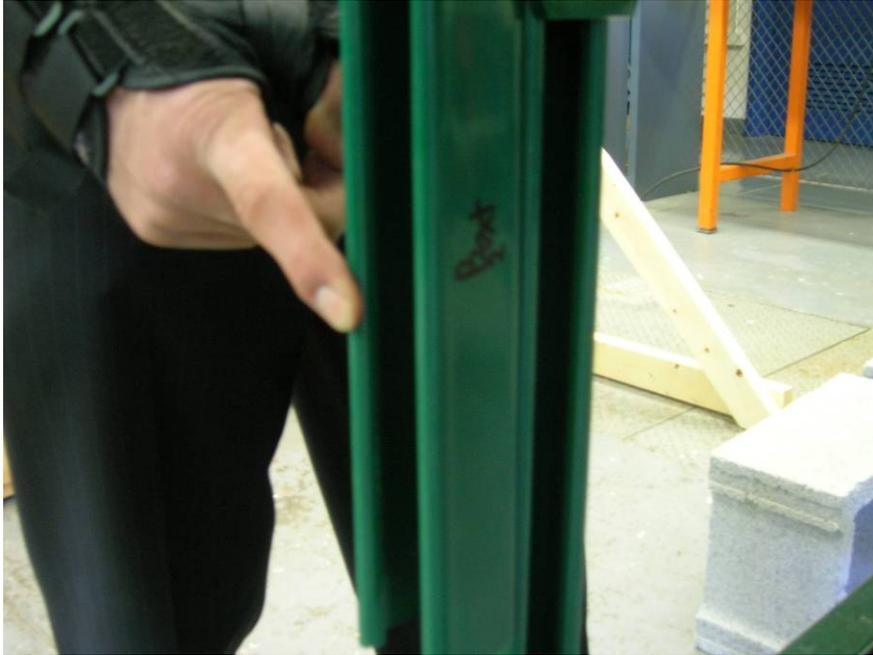
Over half the length of members we had selected when designing our Unistrut Loading Substructure were 1001C sections, whose geometry is shown in figure 10.6.

Figure 10.6: Geometry of P1001C Section

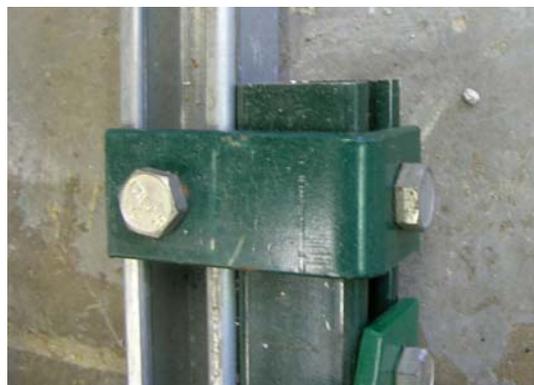
We placed our Unistrut order late, only four weeks before we needed it, and when the order arrived, it contained no 1001C Sections. Extra connectors were used to create alternative ways of connecting single channel members into 1001C-like members, until these, too, ran out. Finally, we had to change our design slightly to accommodate the lack of 1001C sections. The two bulky and imprecise solutions we used are shown below in Figures 10.7 and 10.8.

Figure 10.7: Unistrut 1001C Connector Solution 1

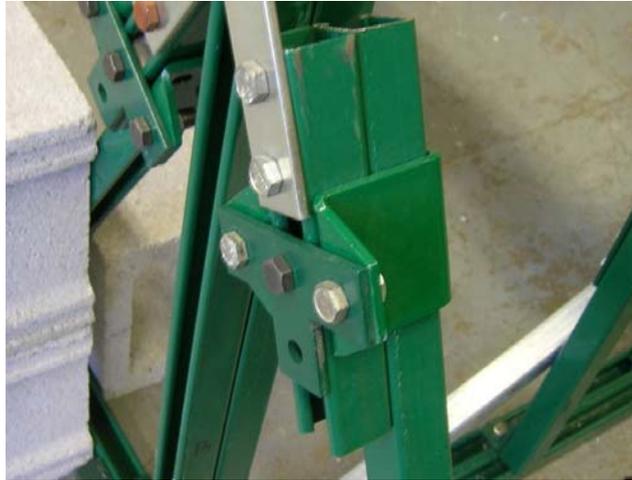
Figure 10.8: Unistrut 1001C connector Solution 2

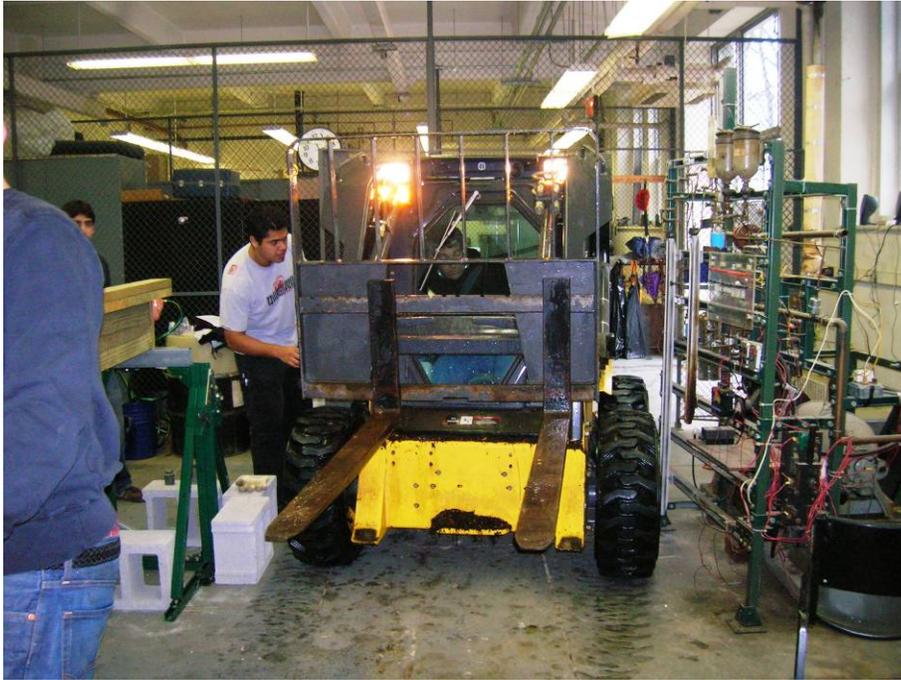
Figure 10.9: Forklift Backing out Carefully

We had measured the clearances of the cage door beforehand to ensure that the Facilities Department forklift could fit. Unfortunately, we did not determine beforehand whether or

not the forklift could actually drop palettes on the bridge and maneuver away. Since it could not, this necessitated some last minute scrambling for manpower, and some sore arms and backs the next day. A picture showing the tightness of the space used by the forklift is shown below in figure 10.9.

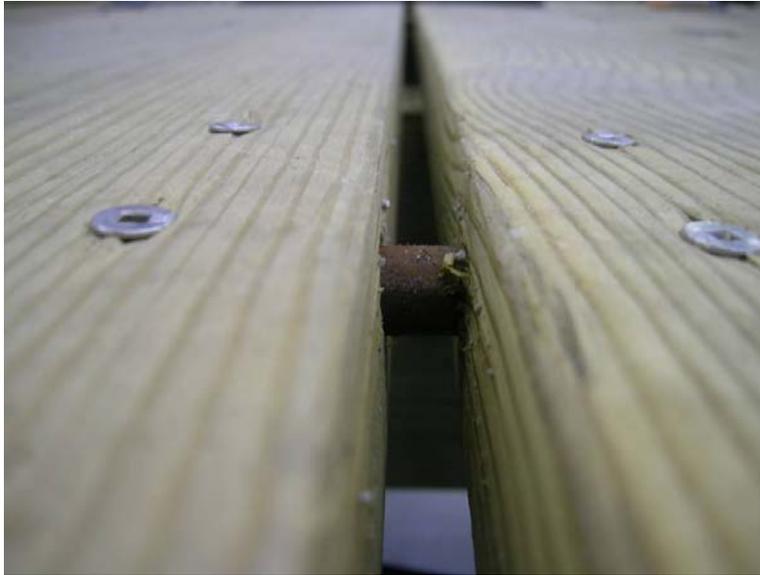
We eventually realized that the dimensioned lumber we had purchased was by no means uniform, often with a variation in height of up to $\frac{3}{4}$ ” between successive 2x10s. Therefore, after gluing 2x10s together to construct our girders, we realized that we were left with far from plane surfaces, which would require many long hours of shimming and planing before it could be used. Had we understood such variables before beginning, we would have run each component through the joiner to achieve plane surfaces of similar heights before gluing.

Figure 10.10: Shrinking of Green Deck Planks Exposing Gaps

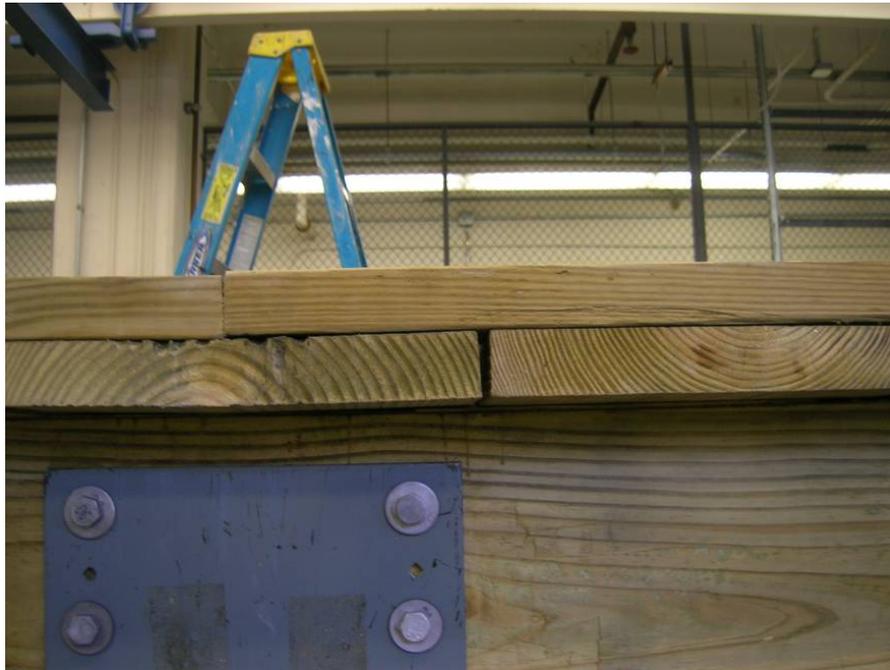
Another issue associated with the wood we purchased was its greenness, or high initial moisture content. This caused two main problems. One was encountered during the drilling of the holes for the cables. The wood was so moist, that the wood was very difficult to drill and in some cases we actually saw steam or water bubbling out of the wood. An even larger issue that we've observed since the loading is the wood amount of moisture the wood has lost. This is evident in that the decking has shrunk significantly leaving large gaps now between the decking boards, as shown in figure 10.10. While this shrinking may be less than desirable aesthetically, and puts some stress on the deck screws, it also guarantees adequate drainage off the bridge deck, and the screws are in no danger of failing.

Figure 10.11: Opposing Grain Orientations on Deck Could Lead to Cupping and Ponding
