The Strawbale House Project at Swarthmore College (1994-1998)

This building was an environmentally innovative structure, constructed mainly out of load-bearing strawbales. It was built by student volunteers, and by undergraduate student members of the 1995 Environmental Studies Capstone Seminar. The building was designed by students in this seminar under the direction of [Professor E. Carr Everbach](#) ([Engineering Department](#)).

Straw Bale Replacement Experiments

The Dismantling of Swarthmore's Straw Bale House

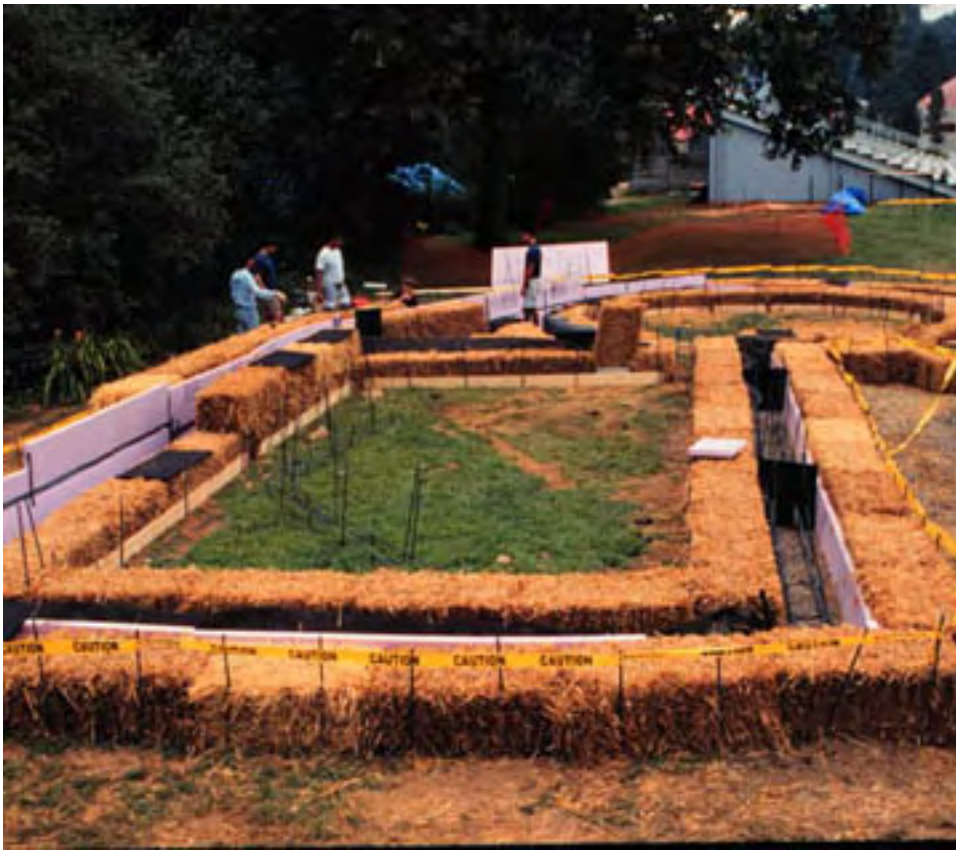
You can see in the above photo that we used straw bales, staked into the ground with rebar, for forms for the foundation concrete pour. The first two courses were impaled on the rebar we left sticking up through the foundation, and subsequent courses were pinned with two stakes per bale of rebar, wood dowels, and bamboo from a local bamboo grove (thanks to the Scott Arboretum). For the round room, bales were bent by placing them over a rock and jumping on them. A plywood bond beam, with two-by-six ears hanging down, was fashioned to sit on top of the top course of bales.

For our foundation, we used a shallow frost-protected foundation consisting of a reinforced concrete beam poured on grade. The 2-in. thick polystyrene foamboard sunk into the ground about two feet deep provided sufficient thermal insulation to prevent water under the foundation from freezing

and causing heaving. Polystyrene is an environmentally undesirable material, but a small amount of it allowed us to avoid the four-foot-deep concrete foundations we would otherwise have had to employ. (For more info about this foundation system, call NAHB at (301) 249-4000).

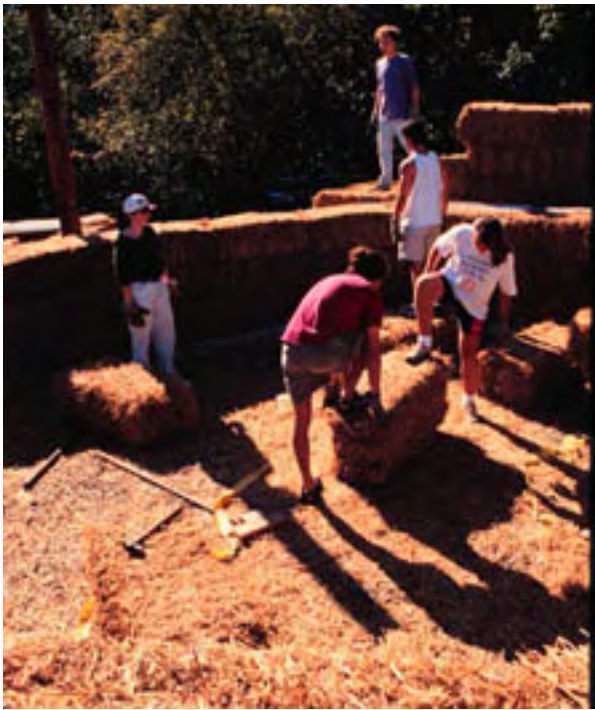
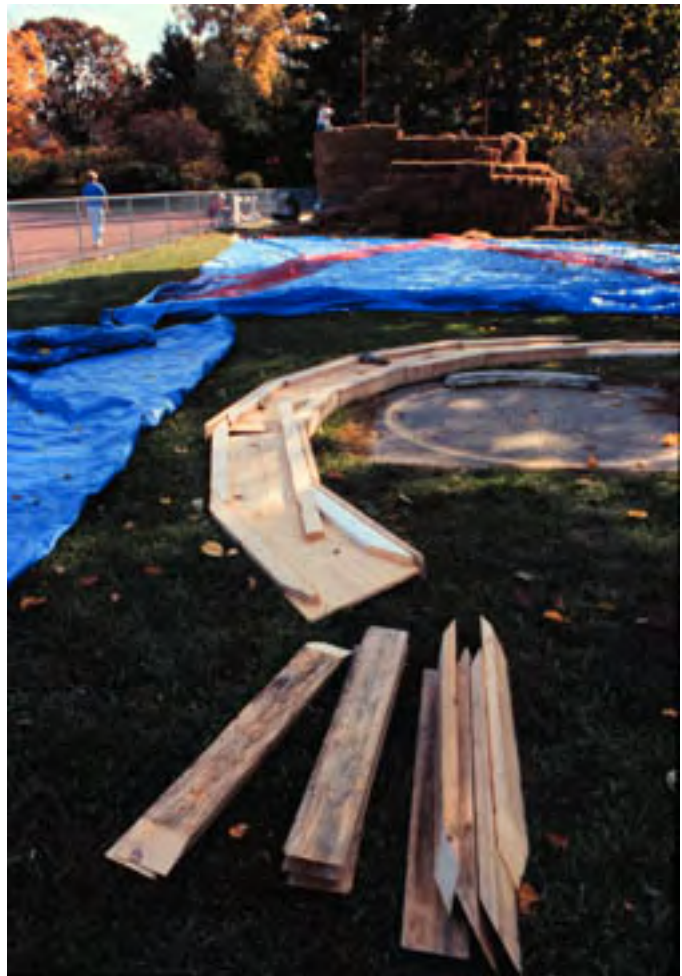
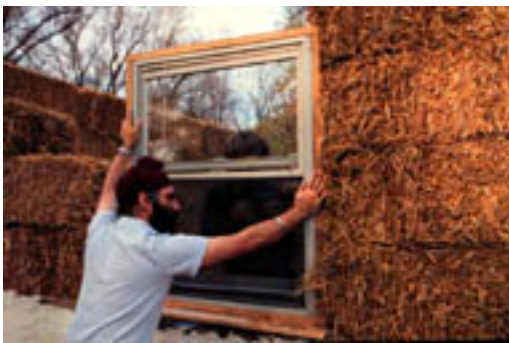
Windows and doors were pinned in place with sharpened wooden dowels and had lintels placed over them to help them bear the roof loads. Lintels consisted of bale-width plywood pieces with steel angle-iron screwed to both (longer) edges. Racking has turned out not to be a problem, probably because the bales we used were especially good (double density: 56 lbs/ bale for a 2-string bale).

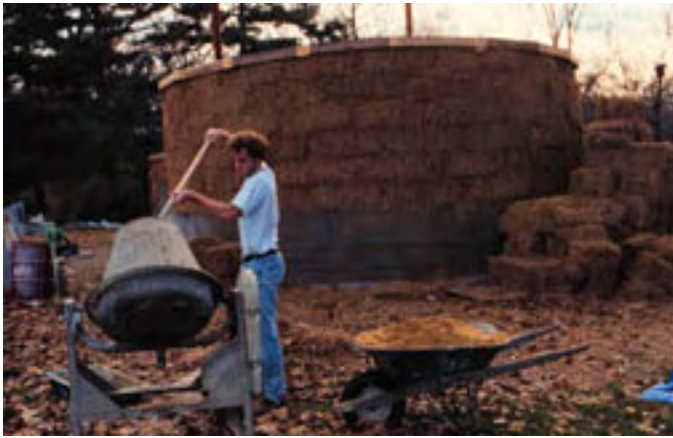
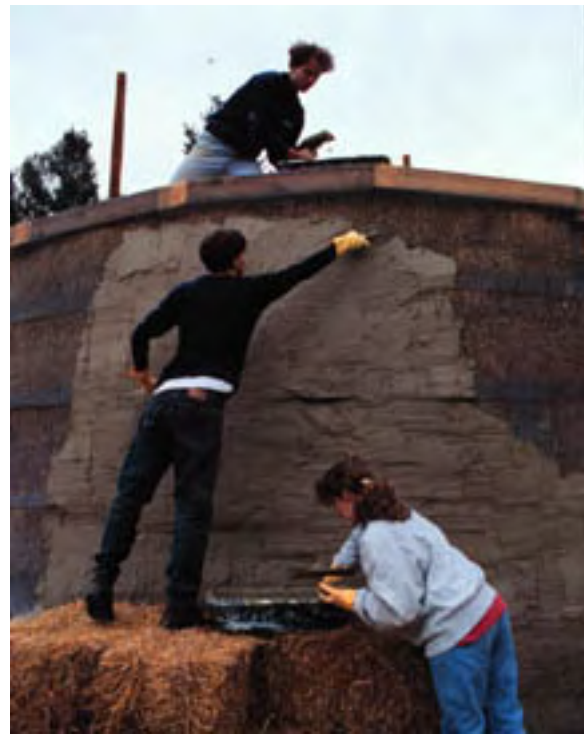
The bales had galvanized steel diamond mesh pinned (with "Robert" pins, since like big bobby pins) to the outside and covered in sand-and-lime stucco (troweled on). We tried various stucco recipes, and our best was: 7 parts bar sand, 2 parts lime, 1/2 part Portland cement, with enough water to reach the right consistency. The cement is environmentally undesirable, but a small amount of it goes a long way to keep the sand and lime together.

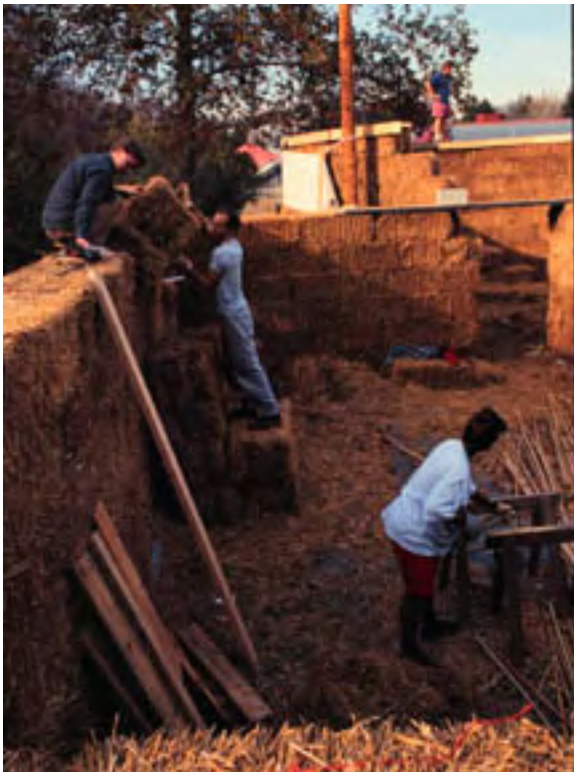
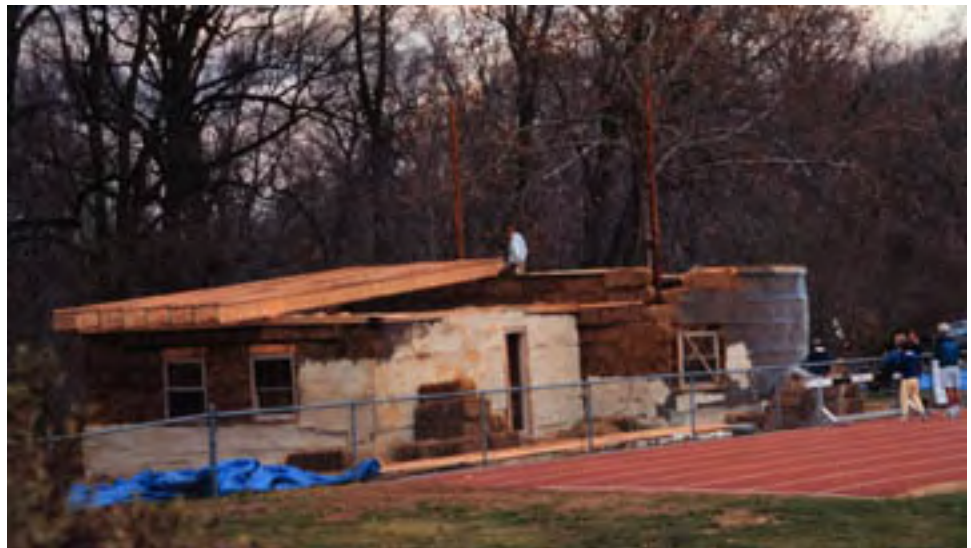
You can see Sylvia Kwake '98 cutting bamboo for pinning bale courses together, below. The roof system was long pieces of pressed wood "I" beams (TGI), which are very strong and lightweight in the vertical direction, bearing upon the bond beams sitting atop the straw walls. Oriented strandboard decking was screwed into place on top, drywall (gypsum board) screwed in underneath, and the gap filled with blown cellulose insulation made from recycled newspapers. Since the TGI beams were 14-in. deep, the R-value of the blown cellulose was calculated to be around 48 (although settling of the cellulose eventually produced a depth of 11 inches, $R = 40$).

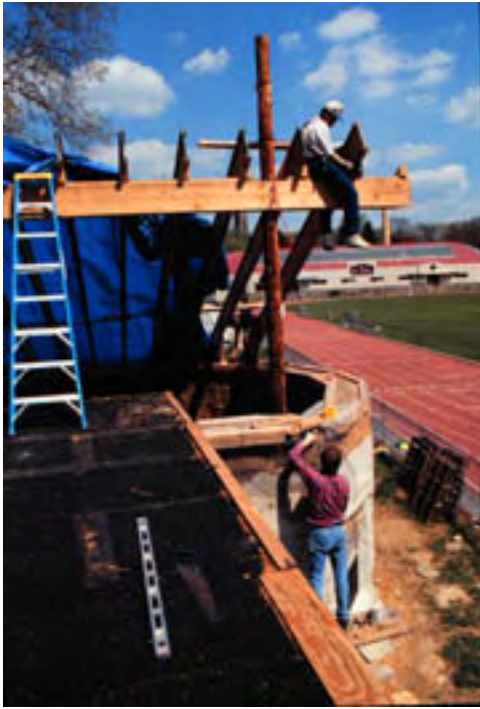
As you can see in the image to the left, the telephone poles were spanned by some two-by-twelves which in turn were used as the bearing surfaces for the upper ends of the round room TGI roof members. Highly energy efficient windows were installed in the clerestory and any wall spaces infilled with straw bales. The roof decking was covered in asphalt roll roofing (neither esthetically or environmentally desirable, but cheap and relatively easy to install with student and volunteer labor). A whitewash-with-pigment color coat was applied to part of the exterior stucco to provide a more uniform appearance, but student (and professor!) energies for esthetic niceties gradually [waned](#) as the building envelope was complete.

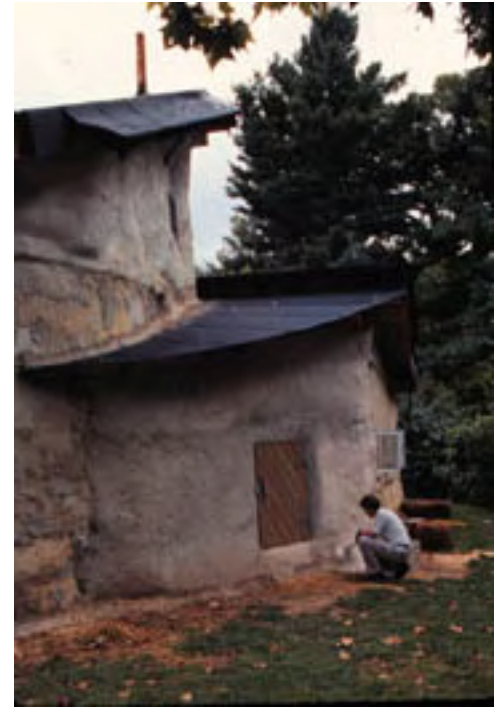
In the interior (round room shown here), slate flagstones were potted in rock dust (for later [easy removal](#)) over 6-mil poly vapor barrier sitting on 4-in. gravel. The flagstones provide a concrete-free solid surface as well as a heat storage element, since sunlight from the clearstory warms them during the day and they re-radiate the heat at night. The walls are currently un-stuccoed, but something like a nice light blue pigment would give the interior space a more homey look. Rebar tiedowns connect some of the TGI roof beams with the concrete foundation and run up the inside walls from floor to ceiling. They are currently exposed but could be encased in plastic pipe or other interior finish.

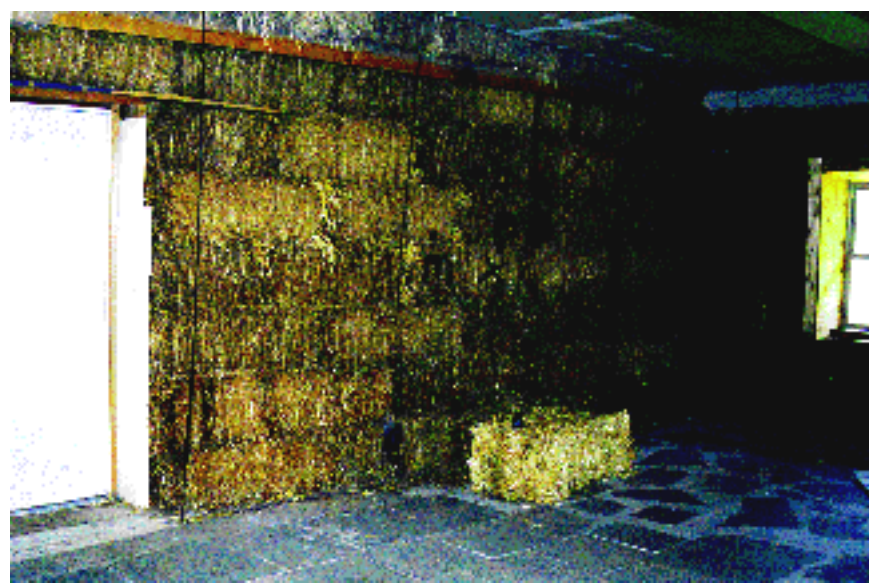
Figure 1, showing non-load-bearing wall marked for in-situ bale replacement. This wall is stuccoed only on the outside surface.

In the non-load bearing wall, Professor E. Carr Everbach selected four adjacent bales (Figure 1).

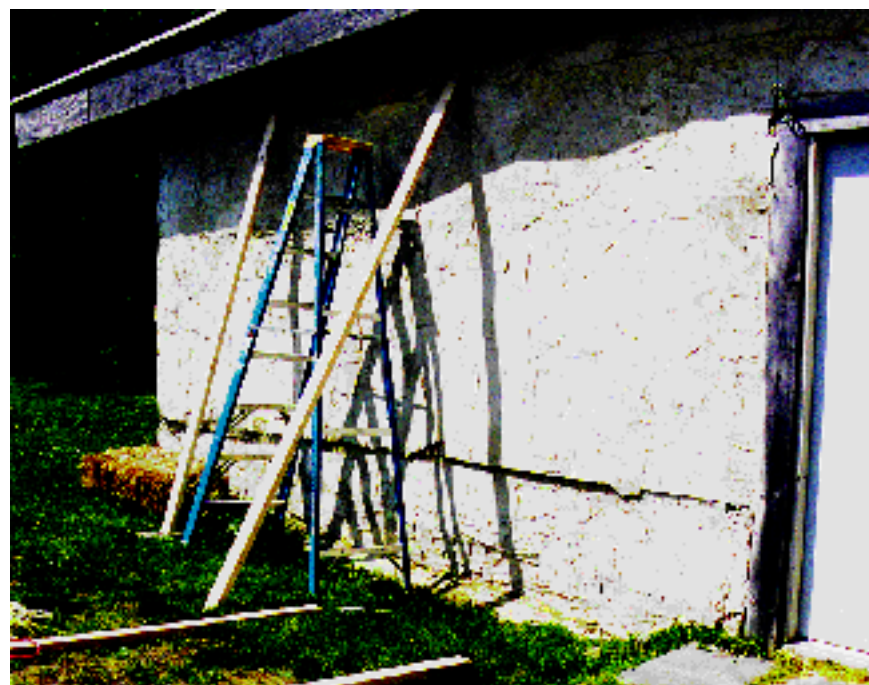
Figure 2, showing non-load-bearing wall outside stucco surface prior to in-situ bale replacement.

Workers ascertained the location of the imbedded support rods within the bales (wood tomato stakes, bamboo poles, or steel rebar) by probing the bales with a thin metal strip. Once pinpointed, the locations of the rods were marked with spray paint on the interior bale surface. Before beginning the bale removal process, the bond beam above the non-load bearing wall was propped up by four ten-foot-long two-by-fours, two on either side of the wall. The two-by-fours provided just enough lift to support any of the minimal roof weight. Access to the four marked bales was limited to the interior side of the wall, as the stucco and diamond lathe barrier covered the exterior side (Figure 2).

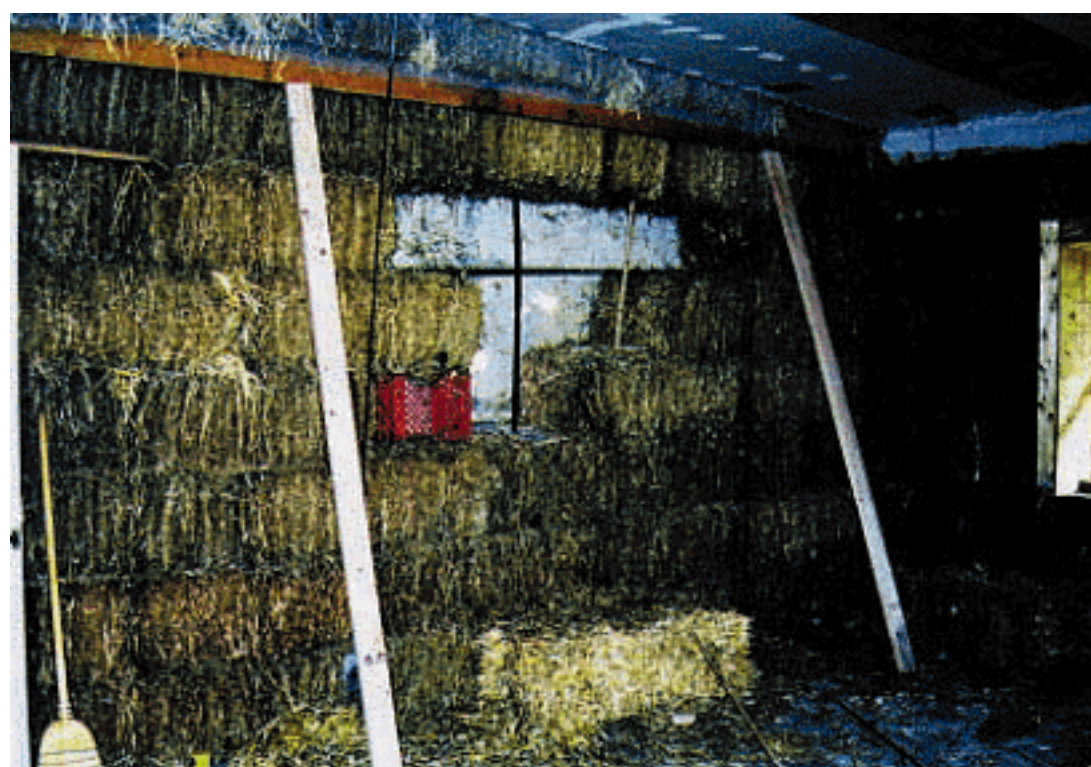
Figure 3, showing four bales removed, with poles (and plastic milk crate) holding up weight of bales above removed ones. Visible in the hole is the underside of the galvanized diamond lathe holding exterior stucco.

Before removing any individual bales, workers needed to cut the bamboo, wood, and steel spikes that were driven through the bales. These rods were located approximately 6-8 inches from the surface of the wall. To reach these supporting rods, the straw constituting the first bale had to be picked out by hand (handsaws aided in loosening the straw to allow for easier access to the rods). Once the rods were exposed, they were cut with an electric saw ("SawsAll"). Sacrificing the first bale allowed for more complete removal of the remaining bales (i.e. maintaining as much of the bales' integrity as possible). The hole left by the removal of the first bale was instrumental in pulling and bending (to a slight degree) the second bale to expose the closest supporting stake. This stake was cut with the electric saw, and a similar bending and pulling technique was employed to reach remaining support rods. Workers were able to pull the second bale up off of the last support rod projecting from underneath to complete its removal. This second bale was completely intact. The third and fourth bales were removed in similar fashion, using pulling and bending techniques to expose supporting rods. Many of these rods could now be pulled out by hand due to the space created by the absence of bales one and two. Rods not loose enough to be pulled were cut as before. Both binding twines of the third bale (upper left) snapped (or were accidentally cut) during the removal procedure. The bale was recovered in a few large pieces. Because of the large gap created by the three missing bales, bales on the upper tier of the wall required additional support to inhibit collapse. Workers used vertical supports of cut wooden stakes or bamboo poles which had been previously extracted before attempting removal of the fourth bale. The fourth bale was then successfully removed.

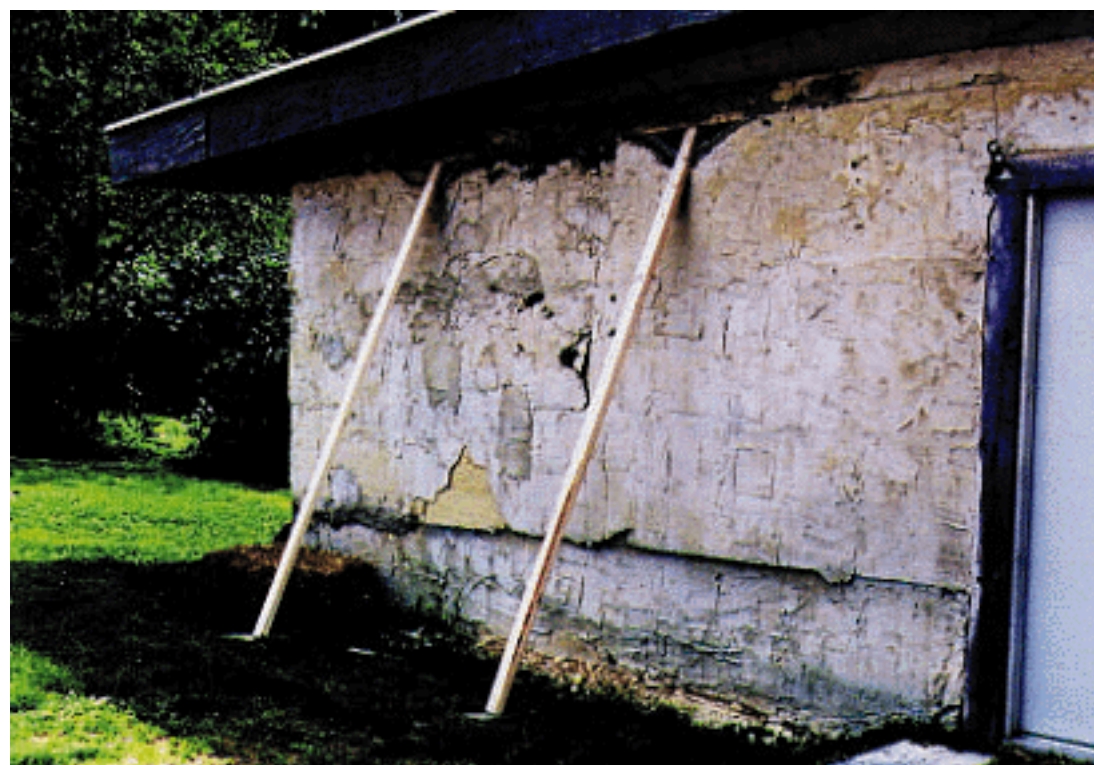
Figure 4, showing outside stuccoed wall after removal of bales. The stucco is cracked and would have to be re-laid after the operation.

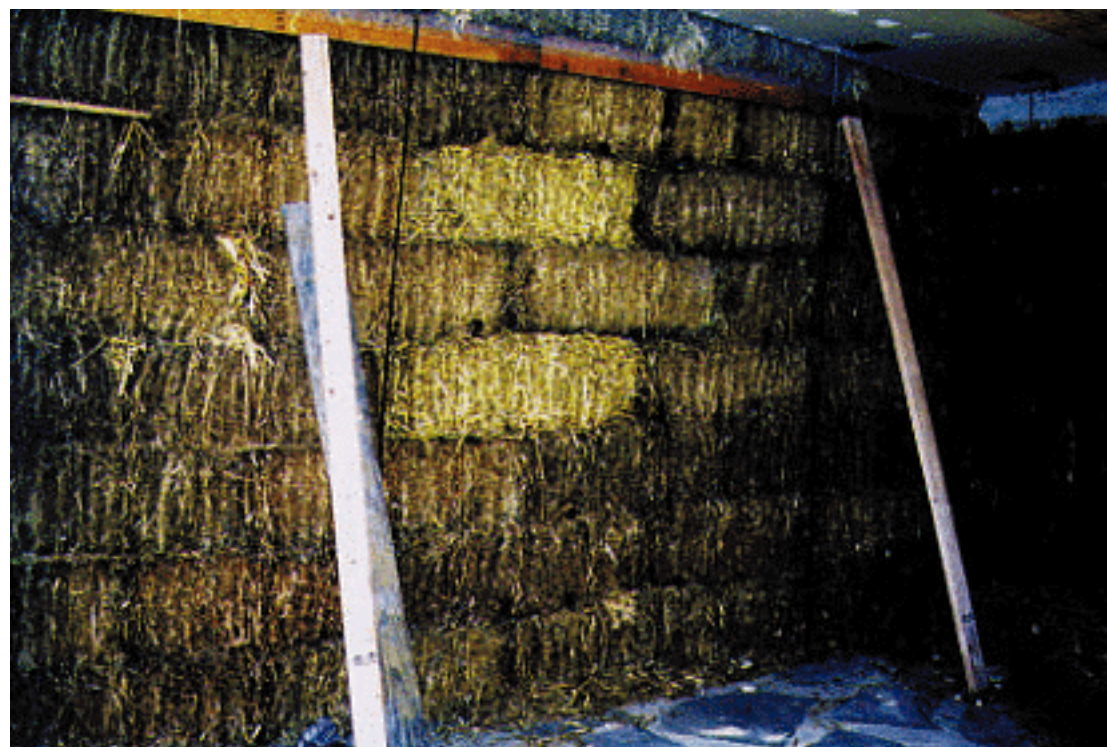
Figure 5, showing completed wall with four new bales inserted. When two-by-fours were removed, the wall settled back to its original configuration with no obvious negative consequences.

The four bales in the non-load bearing wall were replaced in the same order in which they were extracted. Firm, thin metal sheets placed around the new bales were utilized to reduce friction as they were slid into place. The first bale fit easily into the bottom gap, with minimal force. Previously recovered steel rebar spikes were then driven through the new bale to reestablish out-of-plane support. Replacing the second bale required an adjustment of our temporary vertical supports to free the gap. The bale was then shoehorned into place, using the metal sheets as guides, in a similar manner as the first. It was also spiked into place. The third and fourth bales required manual, vertical support of upper bales by one worker as a second fitted the replacement bales into place. The spaces left in which new bales would be positioned were significantly smaller than the previous two gaps, and greater amounts of force were necessary to drive the bales into place (the reduced vertical clearance indicates that compression/settling had made the original bales somewhat less thick vertically than the replacement bales). The new bales were then spiked diagonally from their facing sides up and down into the adjacent bales (Figure 5).

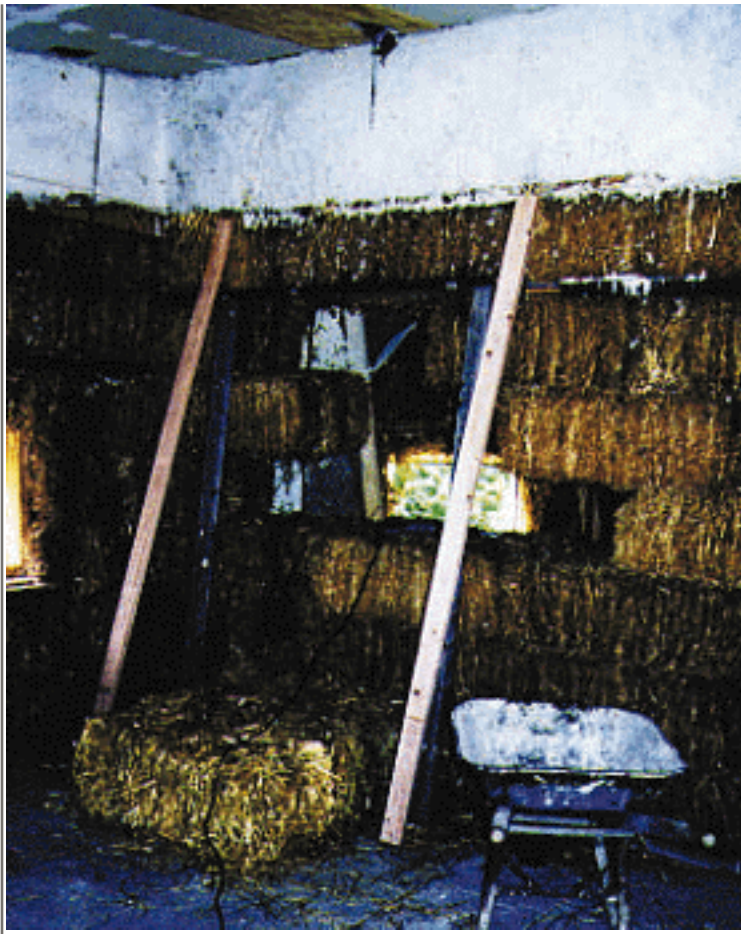
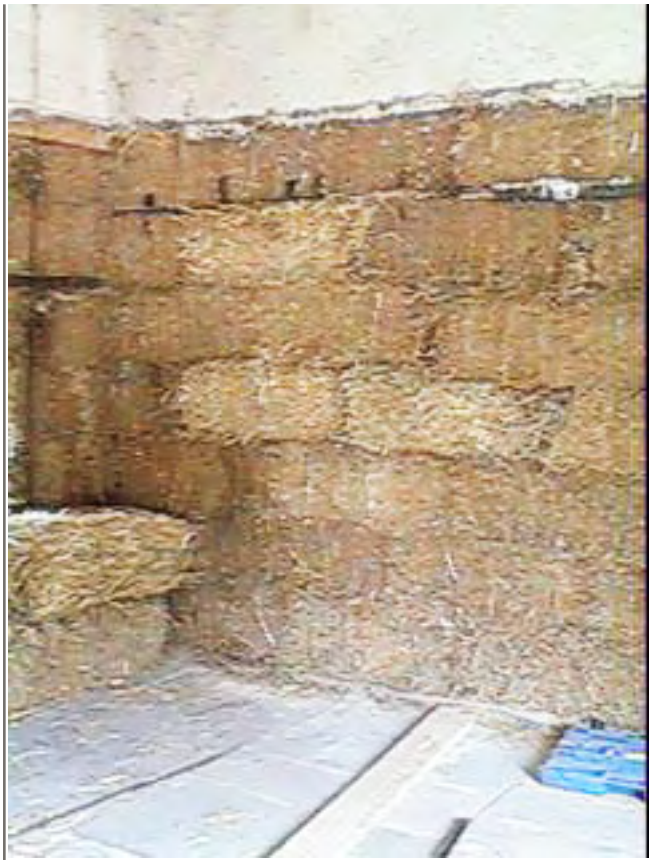
Figures 6 and 7, showing hole in load-bearing wall after removal of five bales, and completed wall with new bales inserted.

Bales were removed from the load bearing wall in a similar manner to those removed in the non-load bearing wall, except the workers were not concerned with keeping these bales intact. Extracting bales in smaller portions expedited the process, and also allowed for easier access to hidden support rods. This extraction process was also aided by an additional two workers (for a total of four) and access to the bales from both sides of the wall (Figure 6).

Bales in the load bearing wall were replaced in a similar manner as those in the non-load bearing wall had been. However, the bales in the load-bearing wall had supported a greater weight than those in the non-load bearing walls. Consequently, bales seemed even more tightly compacted. The vertical gaps for new bales appeared to be significantly smaller than the actual size of the replacement bales (which had not been under such constant and prolonged pressure). Accordingly, more force was required to place the new bales. Again, the advantages provided by four workers and access to both sides of the wall were manifest. Replacement bales were spiked as before with supporting rods. The temporary lintel successfully braced bales on the upper tier, since they did not require additional support as the upper bales in the non-load bearing wall had. When all four bales were in place and the two-by-fours propping up the bond beam were removed, the new bales assumed a noticeably tighter configuration (Figure 7).

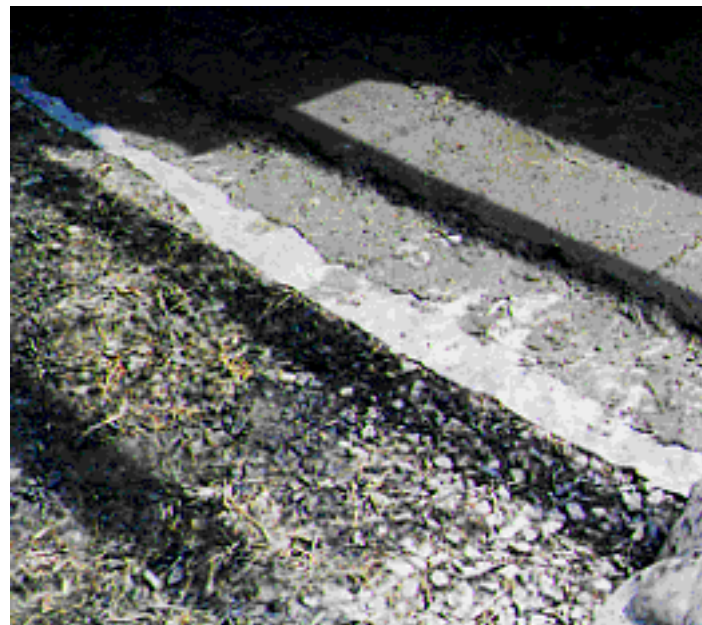
Figure 1: The four layers in the floor: 6 in. of unwashed gravel overlain with 6-mil polyurethane sheet, topped with flagstone slabs potted in about 1/2 in. rock dust

The floor consisted of 6 in. of unwashed gravel overlain with 6-mil polyurethane sheet, topped with flagstone slabs potted in about 1/2 in. rock dust (see Figure 1). We began by prying up the flagstone slabs with a crowbar and transporting them outside with wheelbarrows. The slabs had been sealed down in concrete in one small section of the rectangular room, so we broke those slabs free with a sledge hammer.

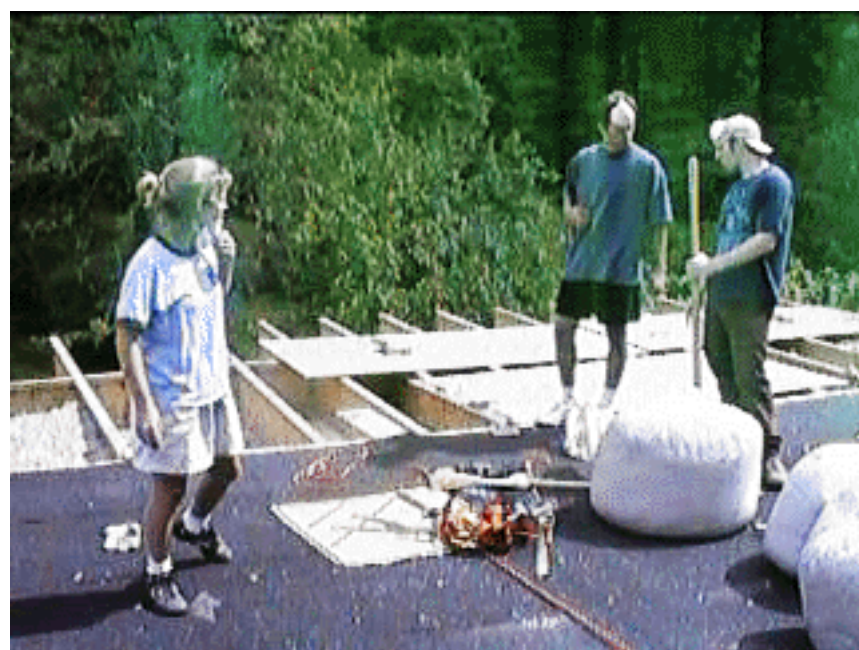
Figure 1: student workers peel off asphalt roll-roofing and pry up oriented-strand-board four-by-eight sheets (1/2 in. thick) to reveal channels holding blown cellulose insulation.

We started on the western-most side of the rectangle room which was the lowest section of the roof. We first began unpeeling the roofing paper to reveal where each of the unweathered 4' by 8' decking started and stopped. We then removed the 3" nails with hammers and used a crow bar to pry up the large sheets of wood. Next we moved up the gradual incline continually removing decking and eventually revealing channels of insulation which lay between the I-beams (see Figure 1).

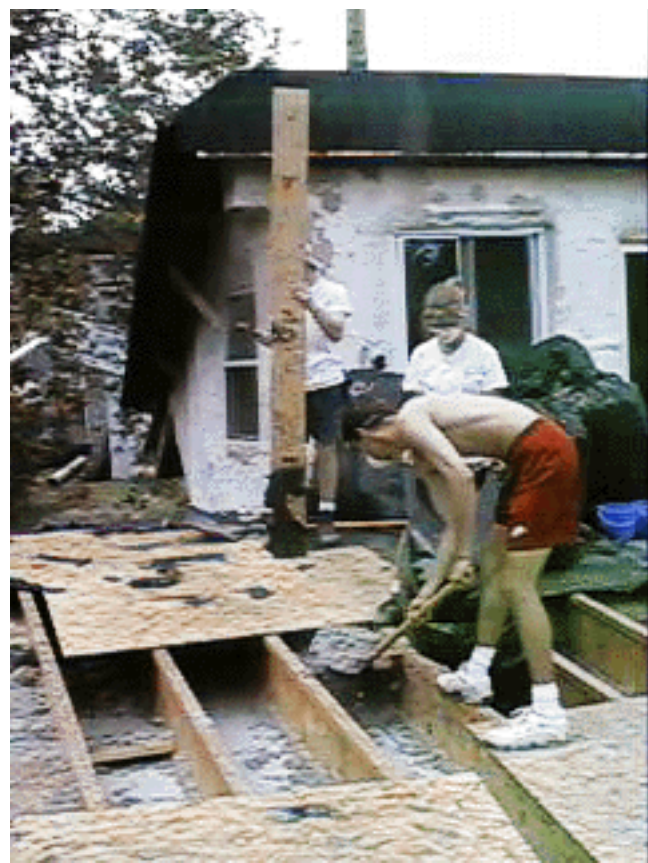
Figure 2. The insulation is shoveled into plastic trash bags.

We used some of the 4' by 8' Oriented Strand Board (OSB) decking as platforms to stand on while shoveling the insulation (see Figure 2). The top layer of insulation had been noticeably discolored, and it had settled tightly in the channel, leaving a 3-inch gap (out of 14 inches total vertical space between drywall ceiling and OSB decking).

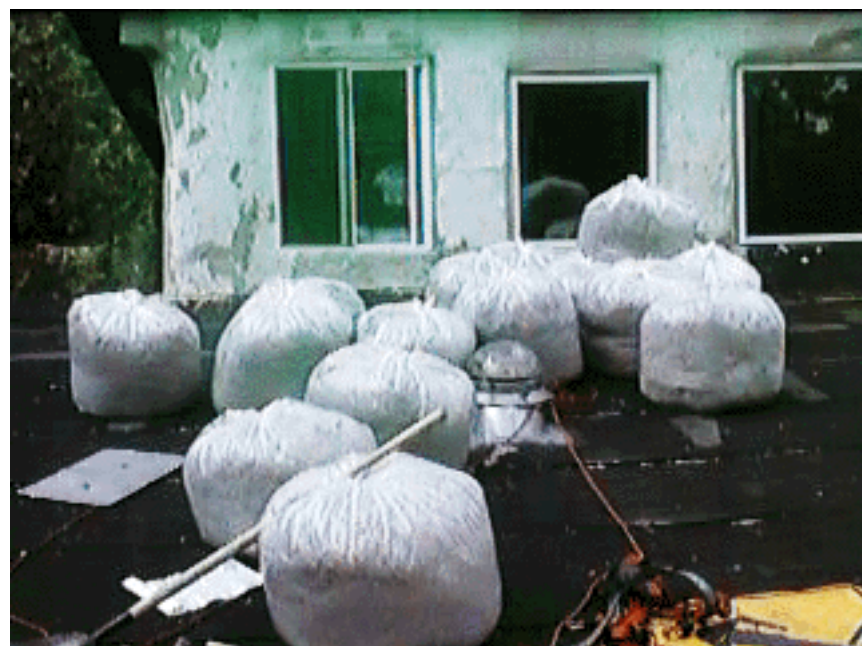
Figure 3: Shown here are bags of blown cellulose insulation ready to be transported for reuse.

After placing the insulation in bags (see Figure 3), we attempted to remove the drywall sheets on the ceiling of the rectangle room. Because of the fragility of the drywall and the countless nails holding the sheets to the bottom of the I-beams, we were unsuccessful at keeping them in reusable condition (see Figure 4). We removed all the decking, roofing material, insulation, and drywall on the rectangle room with the exception of one small section next to the circular room which we kept for access to the slanted roof (see Figure 5).

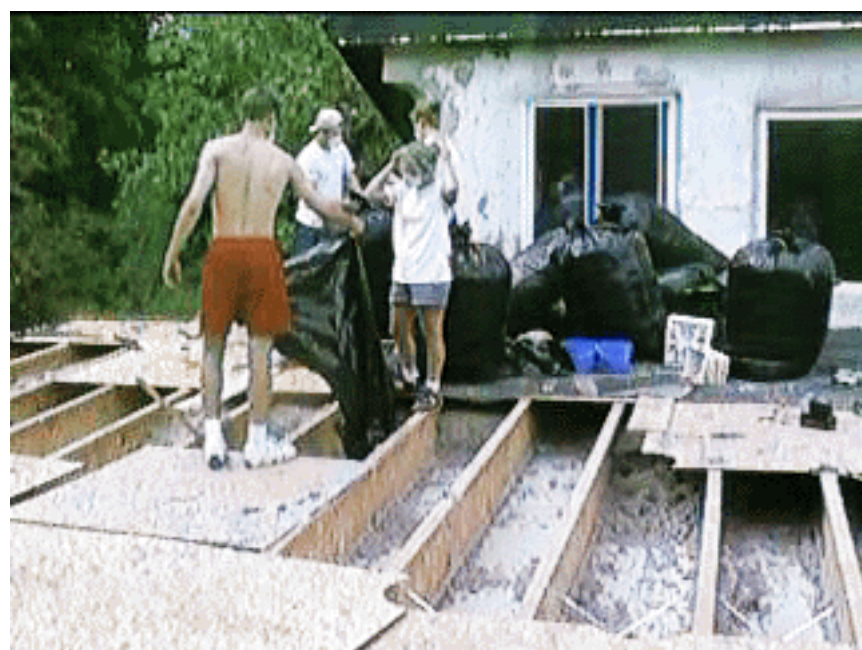
Figure 4: Seen at the bottom of the channels are the sheets of drywall which were too fragile to be taken down in complete pieces.

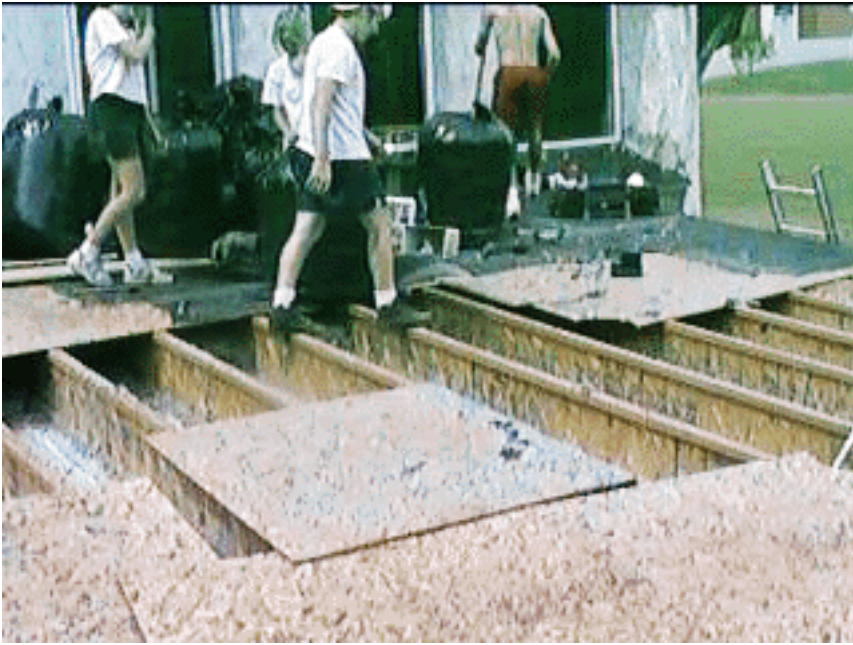
Figure 5: The remaining roof at the top of the picture was left intact to support a ladder which would lead to the top of the roof of the circular room.

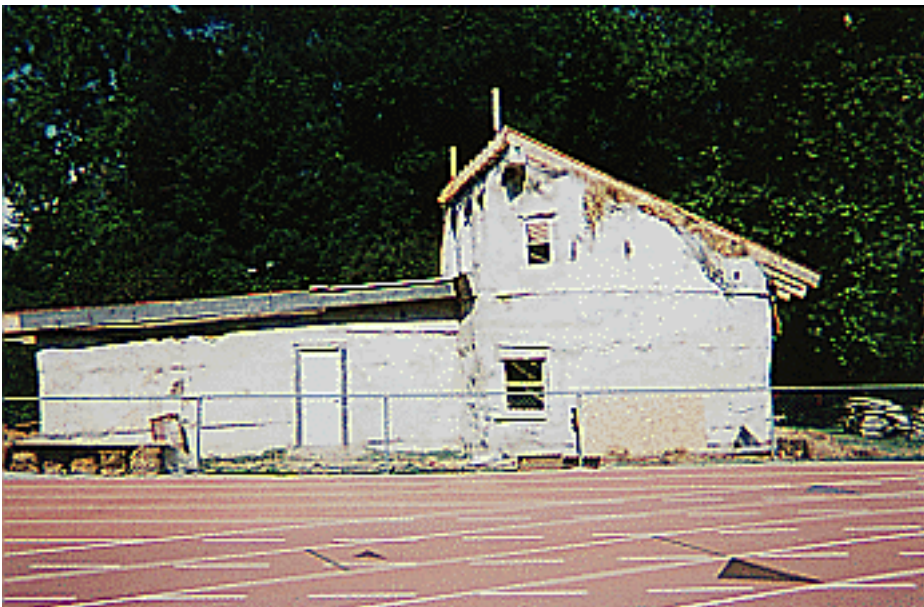
Figure 6: Removing the roof on the circular room was a formidable task because of the steep incline.

The roof above the circular room posed many more complications. The roof was at a 30 degree slant and was up to 10 feet higher from the ground than the rectangular room (see Figure 6). We secured ourselves with body harnesses to the two telephone poles. We also nailed small pieces of 2 by 4's to the decking to serve as foot holds.

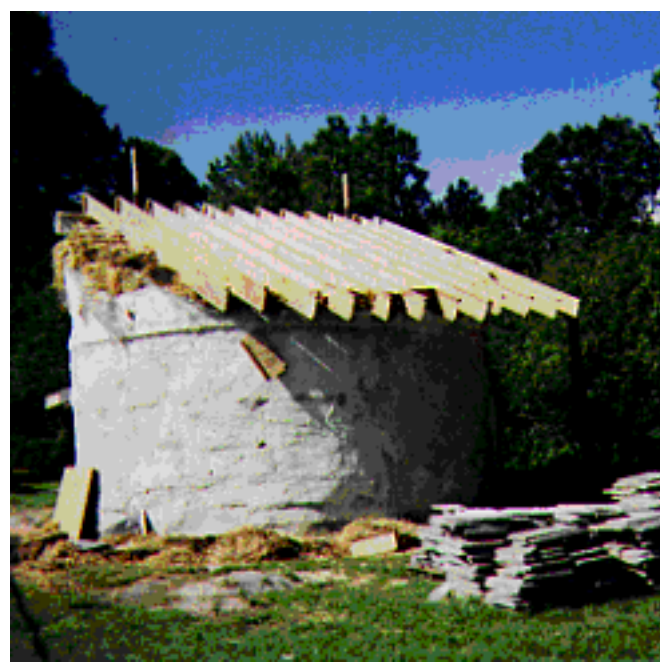
Figure 7: The roof of the circular room after all decking and insulation had been removed.

Once all the drywall, decking, and insulation was removed from the entire house, it was time to remove the I-beams (see Figure 7). But before we could remove them, we first had to remove an overhang off the west side of the circular room. We cut through the 3 or 4 posts supporting it from the bottom, and then we cut through the hinges holding the top of it to the side of the roof. It fell with a tremendous crash.

The 14 inch I-beams were supported by three methods: 1) facia (cut pieces of I-beams 1.5 feet long which filled the gaps between beams on both ends), 2) the I-beams were screwed into the bond beam and extensions from it, and 3) thin metal bracing which zig-zagged among the middle of the I-beams to prevent racking. While there were only nails holding the decking to the I-beams, there were only screws supporting the I-beams in all three of the methods listed above. We started with the beams on the edges and moved inward simply removing all the screws using a phillips head drill bit. We then tossed the 25 feet long I-beams off the roof by pulling them off with rope and by lifting an edge, walking along the bond beam, and tossing the end off the side of the roof (see Figure 8).

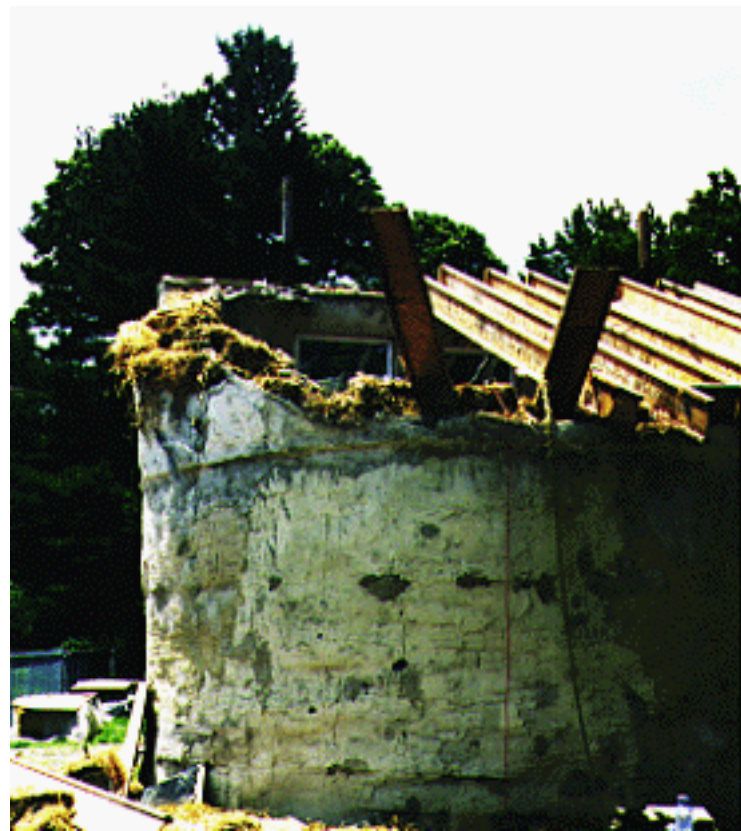
Figure 8: We began removing the I-beams from the side and worked our way toward the middle.

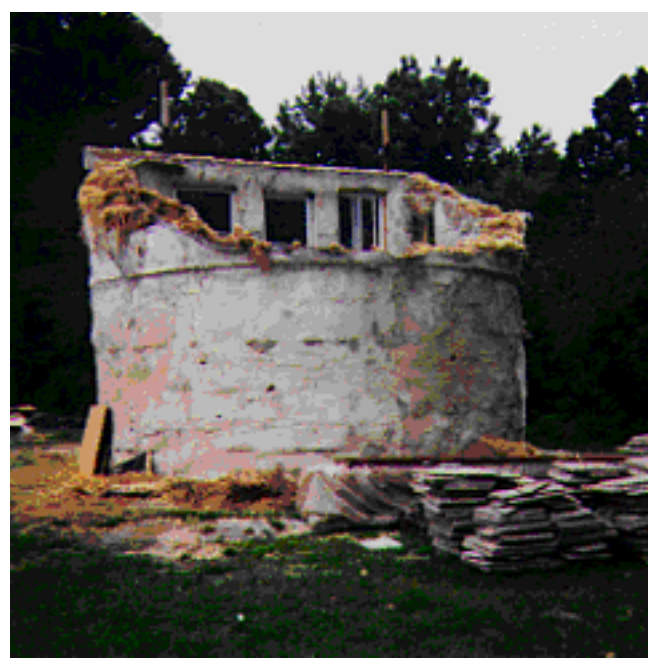
Figure 1: At the top of the Straw Bale House, the four windows comprising the clearstory.

Before we could dismantle the walls, we first had to remove the four clearstory windows at the top of the wall of the circular room (see Figures 1 and 2). Each window sat in a type of 'box' of wood which comprised of 4-6 pieces of wood. The wood was connected to the window on all four sides and acted as a brace in which the window could be secured into the wall. We removed the window on the right by cutting two 2 by 4's; one was slightly longer than the width of the window, and one was slightly longer than the height of the window. The two pieces of wood were hammered into the 'box' to relieve the pressure exerted on the windows by the surrounding wood. The window could then be pushed out. The other three windows were removed by simply cutting all rubber cement, nails, wire lathe, and screws holding them to the surrounding wood. We then tied ropes around the large windows after gently rocking them out of their confinements, and we lowered them to the ground. After removing all the windows, it was easy to remove all the wood and bales which supported the top part of the wall.

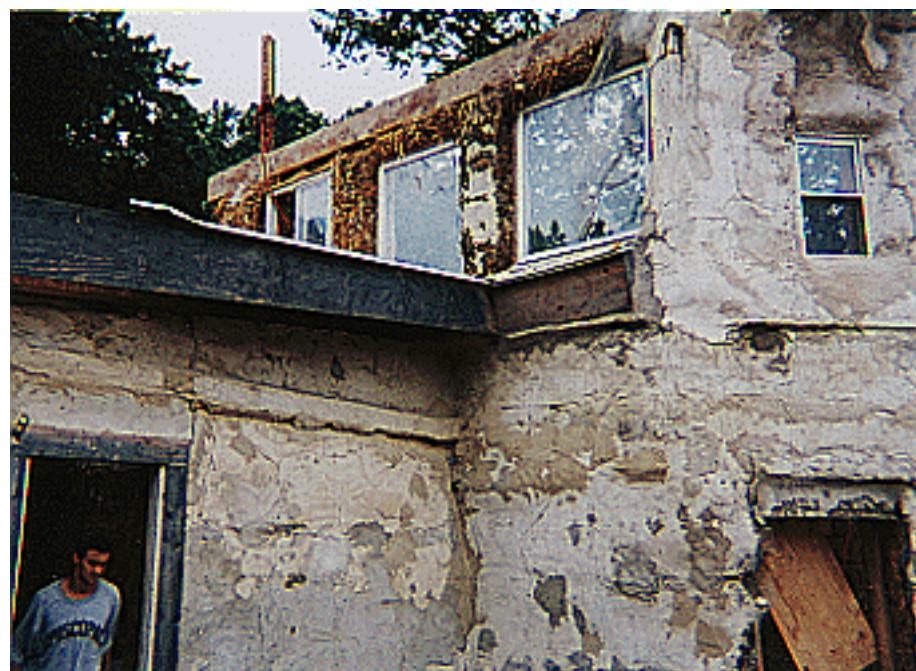
Figure 2: The clearstory windows from the opposite direction. Wooden frames held the window in the walls of straw and wooden beams.

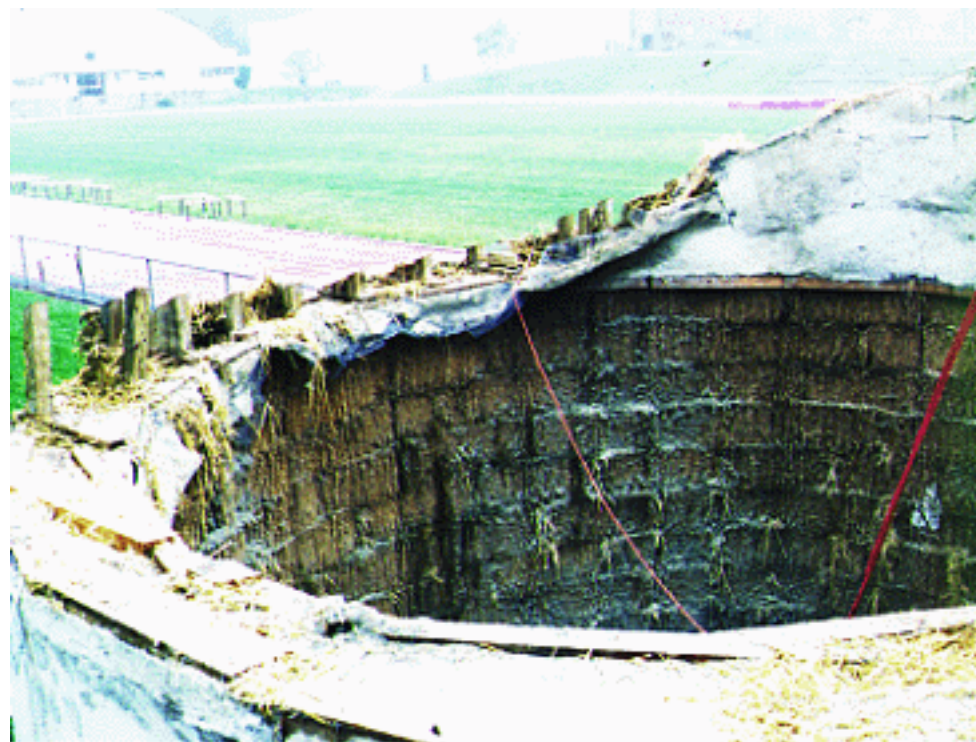
Figure 3: The bond beam which encompassed the top of the circular wall.

Our next step was to remove the bond beam which encompassed the the top of the circular wall (see Figure 3). We cut it into six large sections and heaved each part off the wall, bringing some of the connected wire lathe with them (see Figure 4). The wire lathe plastered with stucko covered all the walls, yet it came off rahter easily when we pulled it down in large sections. Most of the stucko

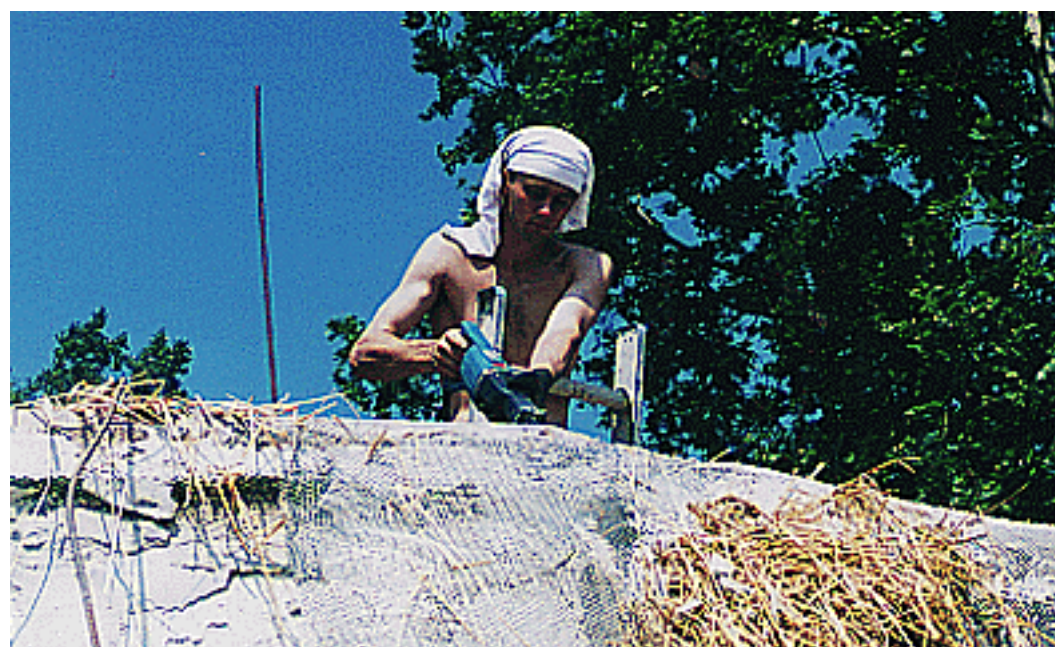
Figure 4: A worker cuts the bond beam into sections. As the bond beam is pushed off the top of the wall, it would pull down the wire lath connected to it.

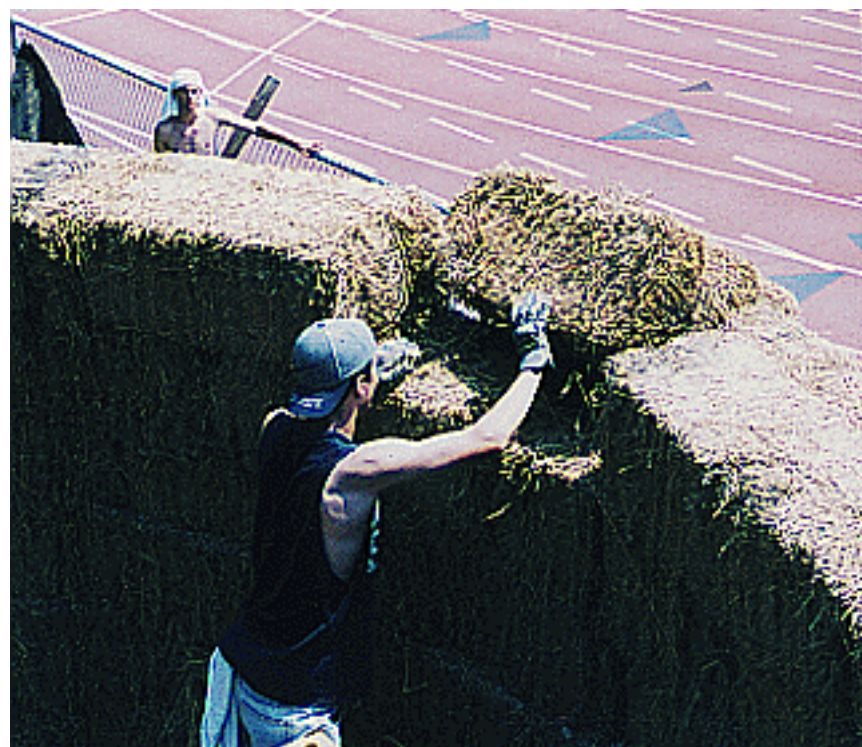
Figure 5a: A Straw Bale worker removes the very first bale.

Eventually, all that was seen was a large open cylinder of straw bales. Each 40" by 21" by 16", 54 lbs bale had approximately two or three lengths of steel, wood, or bamboo supporting it into the bales below. With one person on both sides of the bale pulling up on the plastic string, the bales could be yanked straight up out of their confinement (see Figures 5a and 5b). The removed bales were stacked and covered with a tarp.
