The Strawbale House Project at Swarthmore College (1994-1998)

This building was an environmentally innovative structure, constructed mainly out of load-bearing strawbales. It was built by student volunteers, and by undergraduate student members of the 1995 Environmental Studies Capstone Seminar. The building was designed by students in this seminar under the direction of [Professor E. Carr Everbach](#) ([Engineering Department](#)).

Straw Bale Replacement Experiments

The Dismantling of Swarthmore's Straw Bale House

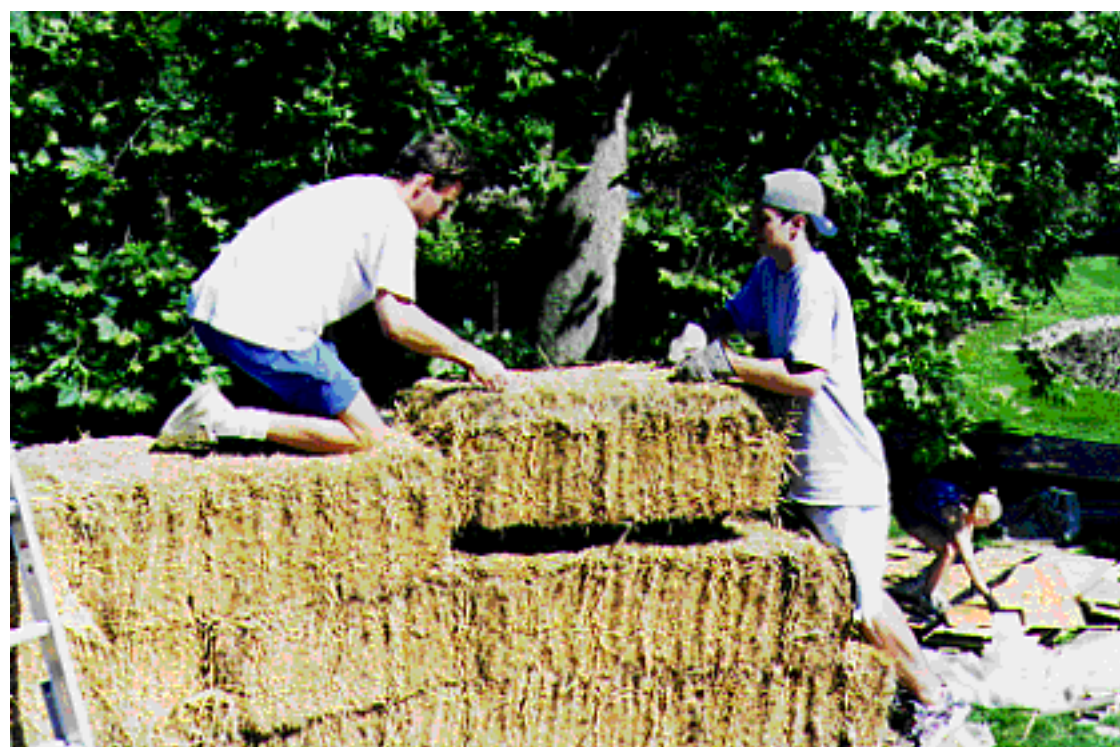
Figure 5b: Straw Bale workers John Leary (L) and Josh Bramucci (R) remove a bale.

Eventually, all that was seen was a large open cylinder of straw bales. Each 40" by 21" by 16", 54 lbs bale had approximately two or three lengths of steel, wood, or bamboo supporting it into the bales below. With one person on both sides of the bale pulling up on the plastic string, the bales could be yanked straight up out of their confinement (see Figures 5a and 5b). The removed bales were stacked and covered with a tarp.

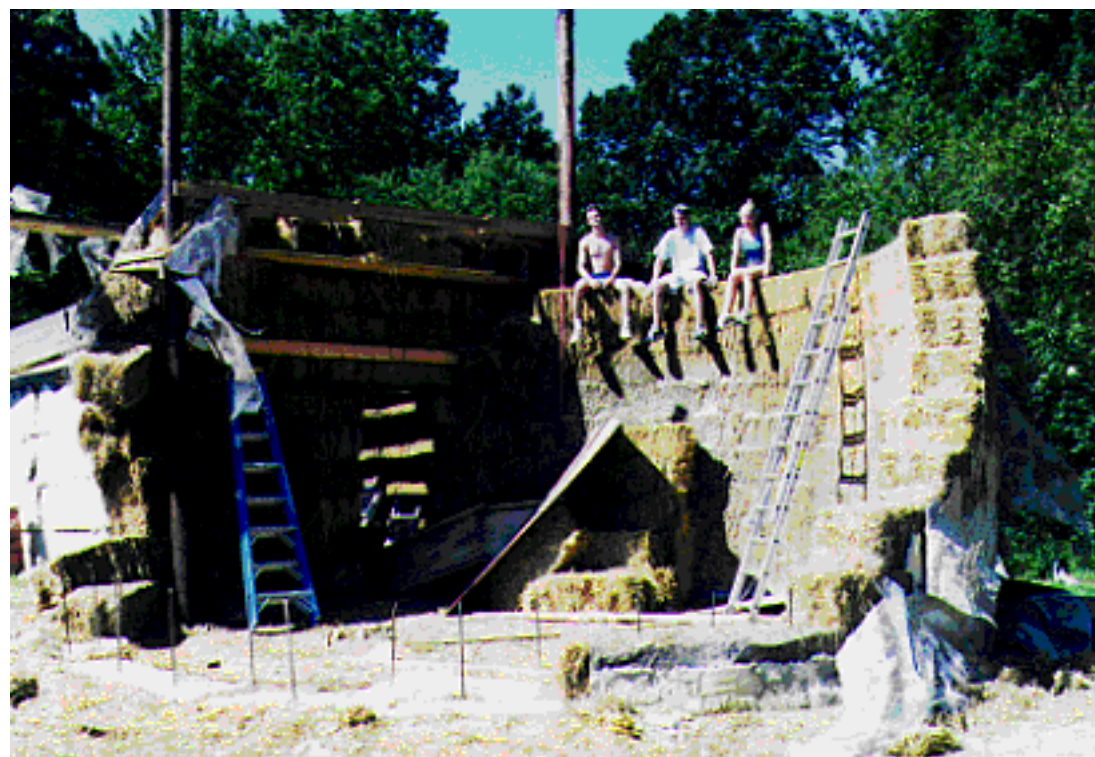
Figure 6: The wall was removed in a counterclockwise direction.

We preceded removing bales in a counterclockwise direction around the room (see Figure 6) until we reached the area where the triangle room meets the circular room. We then concentrated our efforts on removing the triangle room before we finished with the circular wall.

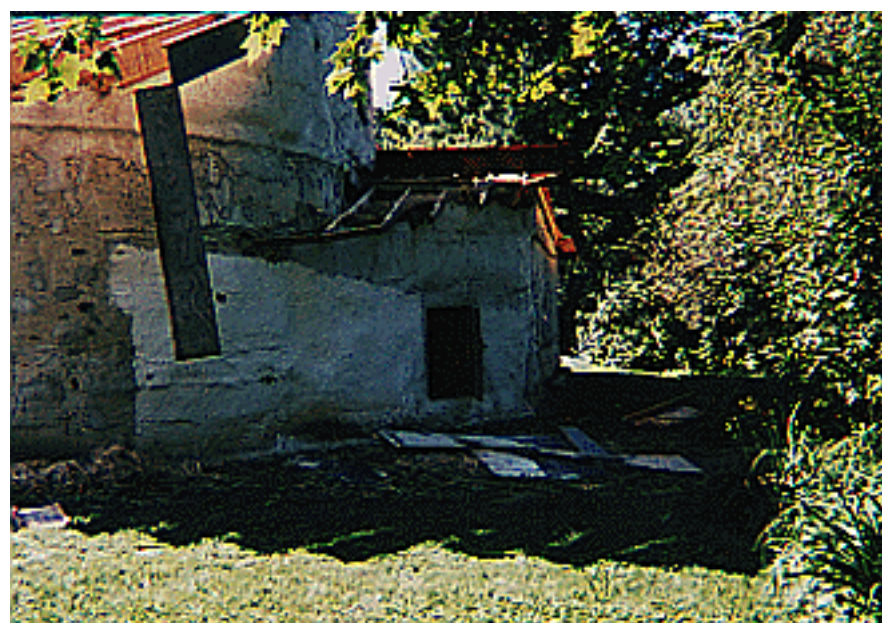
Here is a picture of the triangle room with only the decking removed:

The decking of the triangle room was removed in a similar manner as all the other decking. 2 by 4's, supporting the decking, stretched across the distance of the small room. Those 2 by 4's were connected to the wall of the rectangle room and the bondbeam over the outside wall of the triangle room. All of those pieces of wood were easily unscrewed and removed. The bond beam over the wall was easily lifted off, and the bales of the wall were removed in the same manner as the bales of the circular wall.

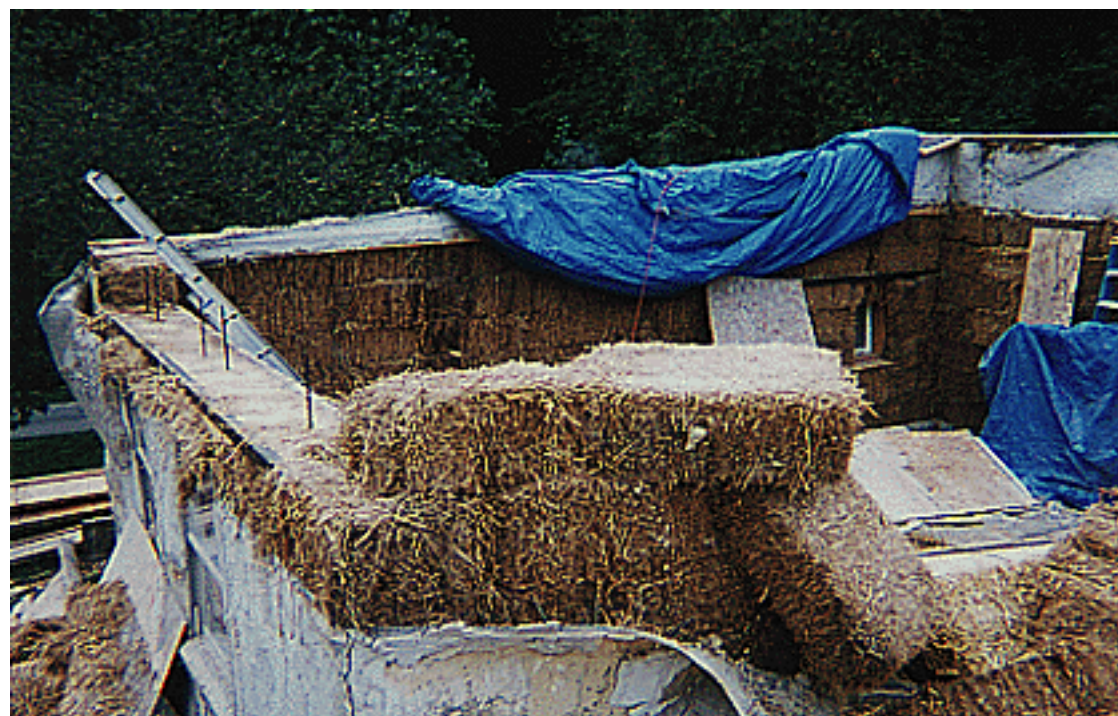
Figure 1: Seen here is the bond beam on top of the rectangle wall.

The four bond beams on the walls of the rectangle room were simply secured by the weight of the roof, so they were easily pushed off the tops of the walls (see Figure 1). The bales were removed in the same manor in which the bales of the circular room were removed.

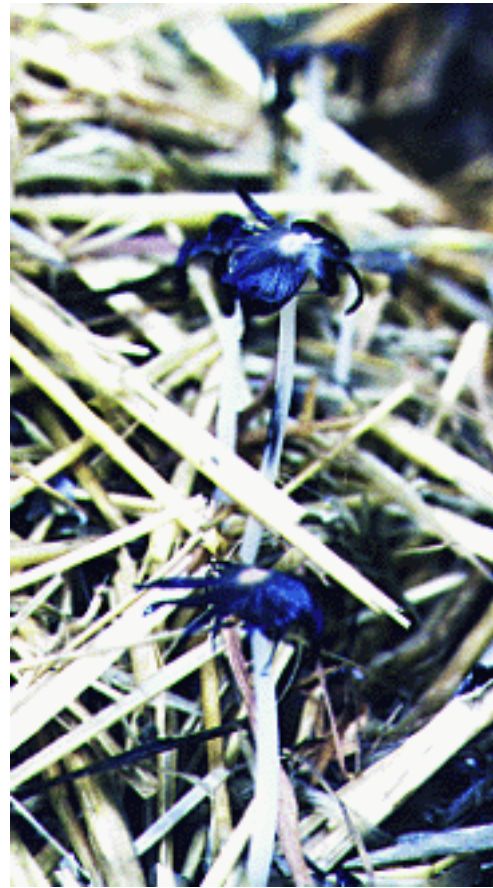
Figure 3: The mold fungus, with flower, that grew on some bales that had been lying outside the house for several years.

In straw bale structures, mold infestations can become very problematic. In the presence of moisture, molds can readily attack and degrade the cellulose fibers of which straw bales are made, weakening the supporting walls. If left uninhibited, and if moisture remains, mold spores may spread, further weakening walls while inviting infestations of mold-devouring insects. Any water leakage into bale walls, therefore, may necessitate the prompt removal of the plagued bales (unless complete drying is possible) before wall conditions degrade to a dangerous degree. These experiments investigated the possibility of *in situ* straw bale replacement on load-bearing and non-load-bearing walls in the (Nebraska-style) Straw Bale House at Swarthmore College.
